Project
Ferry Lane Level Survey and Drainage Survey

Drawing Title
Ferry Lane Level Survey and Drainage Survey Results

Drawn by	J S Dawson-Parry	e-mail	jparry@warrington.gov.uk
Approved by	J W Turton	Telephone	01925 442534
Date	04 April 2016	Fax	01925 443255
Sheet	1 of 1		
Scale	1:500 @ A2		
Drawing No.	LD2016/006/002		
Phase / Revision

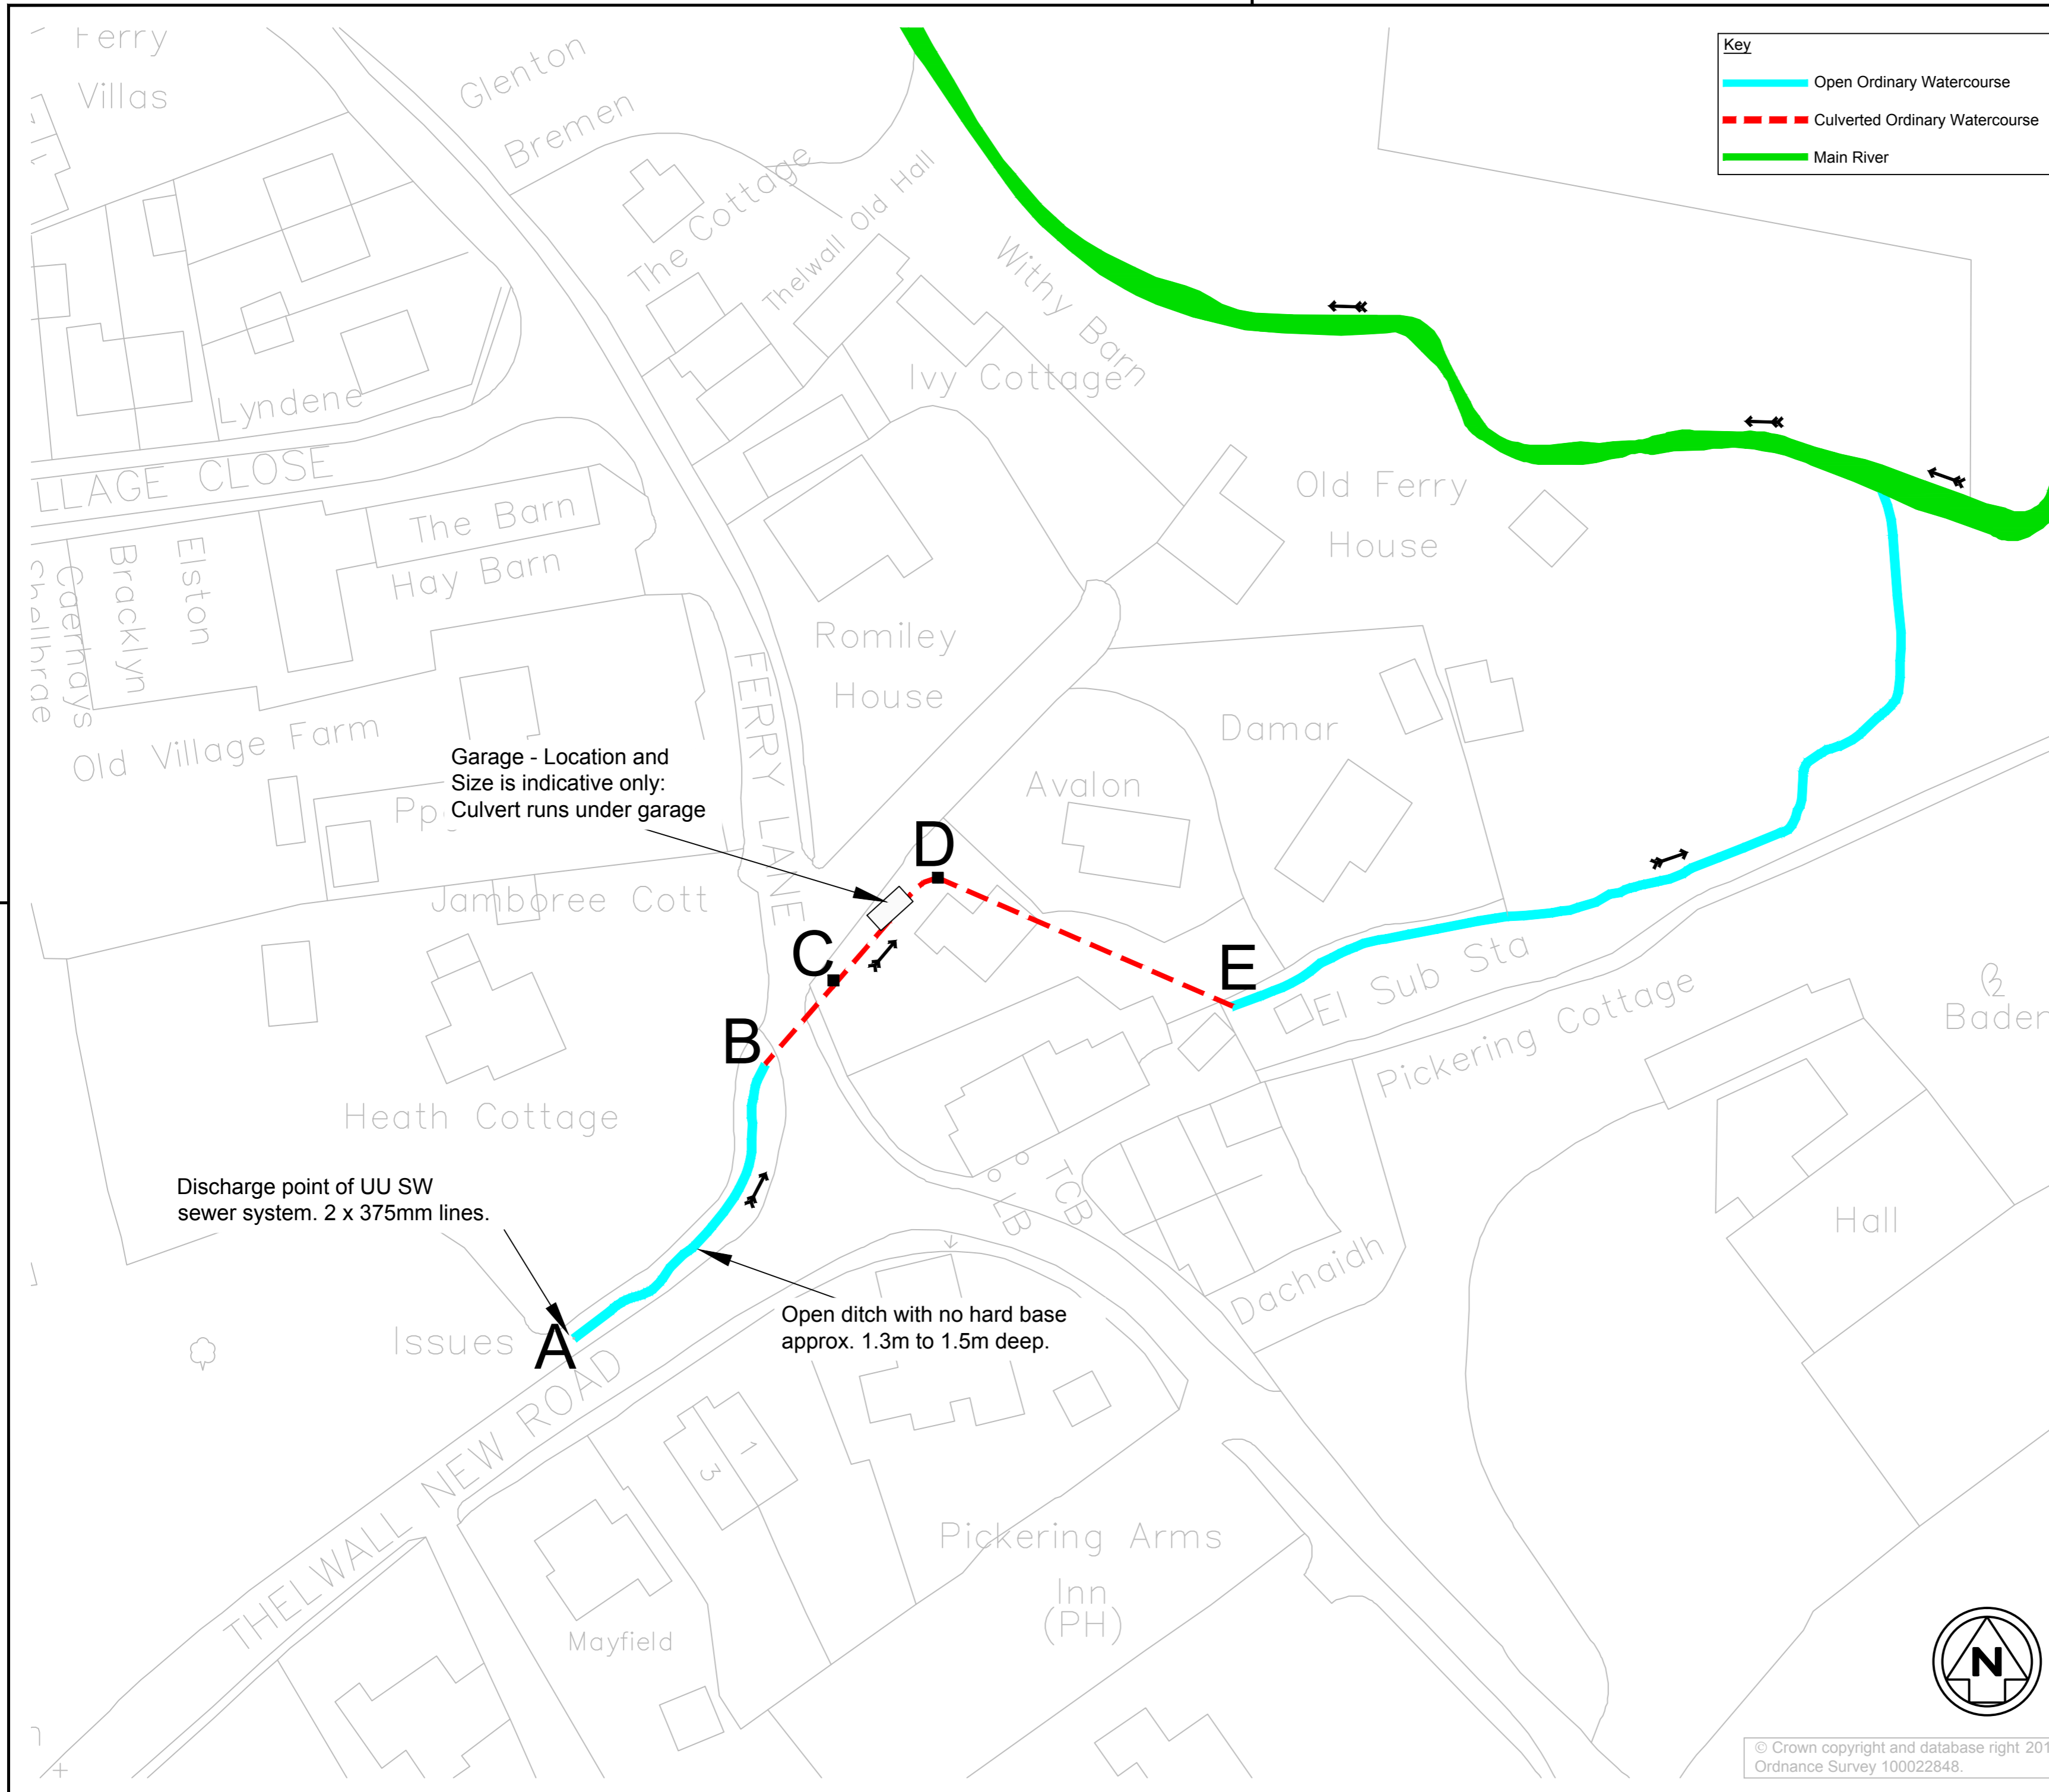
B to C
 Culvert is constructed from random course masonry with slab top and is approximately 800mm x 900mm in size and 11m in length.

Culvert is in good condition however there are a number of utility services cutting through the culvert in a north south direction which at the time of survey were observed to have caught branches but not causing an obstruction to flow. (Debris removed following survey).

C to D
 Culvert is 525mm diameter concrete pipe and approximately 18m in length.

Culvert is in very good condition but has some fine roots at two of the pipe joints.

Pipe has an approximate fall of 1 in 120.

D to E
 On first inspection the culvert was partially blocked due to siltation/debris towards the outfall into the Ordinary Watercourse. It is most likely that the silt/debris material was pushed back upstream by the rising water during the flood event on 26 December 2015. The Contractor on behalf of the Council undertook jetting in order to clean the culvert.

Culvert is 600mm diameter concrete pipe and approximately 36m in length.

Culvert is in good condition but has some fine roots at four of the pipe joints and a poor incoming connection.

Pipe has an approximate fall of 1 in 107.

E - Headwall Comments
 Headwall was observed to be blocked by debris and in poor condition during CCTV survey/cleaning (debris removed to allow CCTV survey to be undertaken). During site visit on 30 March 2016 by JDP & JWT, headwall was observed to have partially collapsed.

It is the intention of the Engineering & Flood Risk Team to install a trash screen at the upstream end of the culvert to reduce the amount of debris entering it and reduce the risk of blockage.

It is the intention of the Engineering & Flood Risk Team to identify owner of headwall and discuss appropriate repairs.
