# Conservation Area Appraisals: Buttermarket Street

Warrington Borough Council, Environment Services Directorate  
Planning Policy Division

MARCH 2007

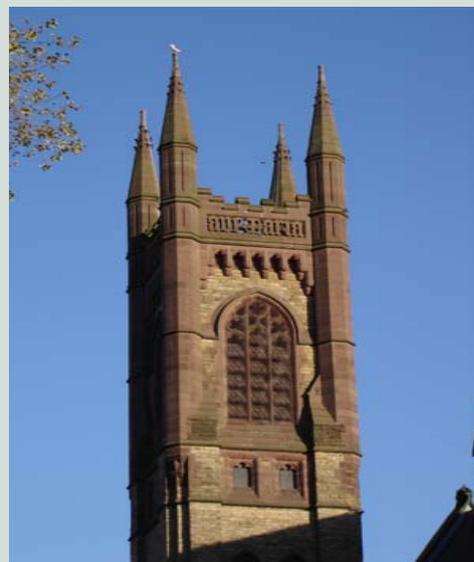
St. Mary's R.C. Church dates from 1877, in decorated style by Pugin and Pugin, considered by Pevsner to be one of their best works. The body of the Church is in coursed buff sandstone rubble ; smooth faced pink stone is used for windows, band courses and other details. The very tall and slender north east tower by Peter Paul Pugin was added in 1906. A notable feature of the tower is the balustrade formed of the wording "Ave Maria" in pink sandstone.

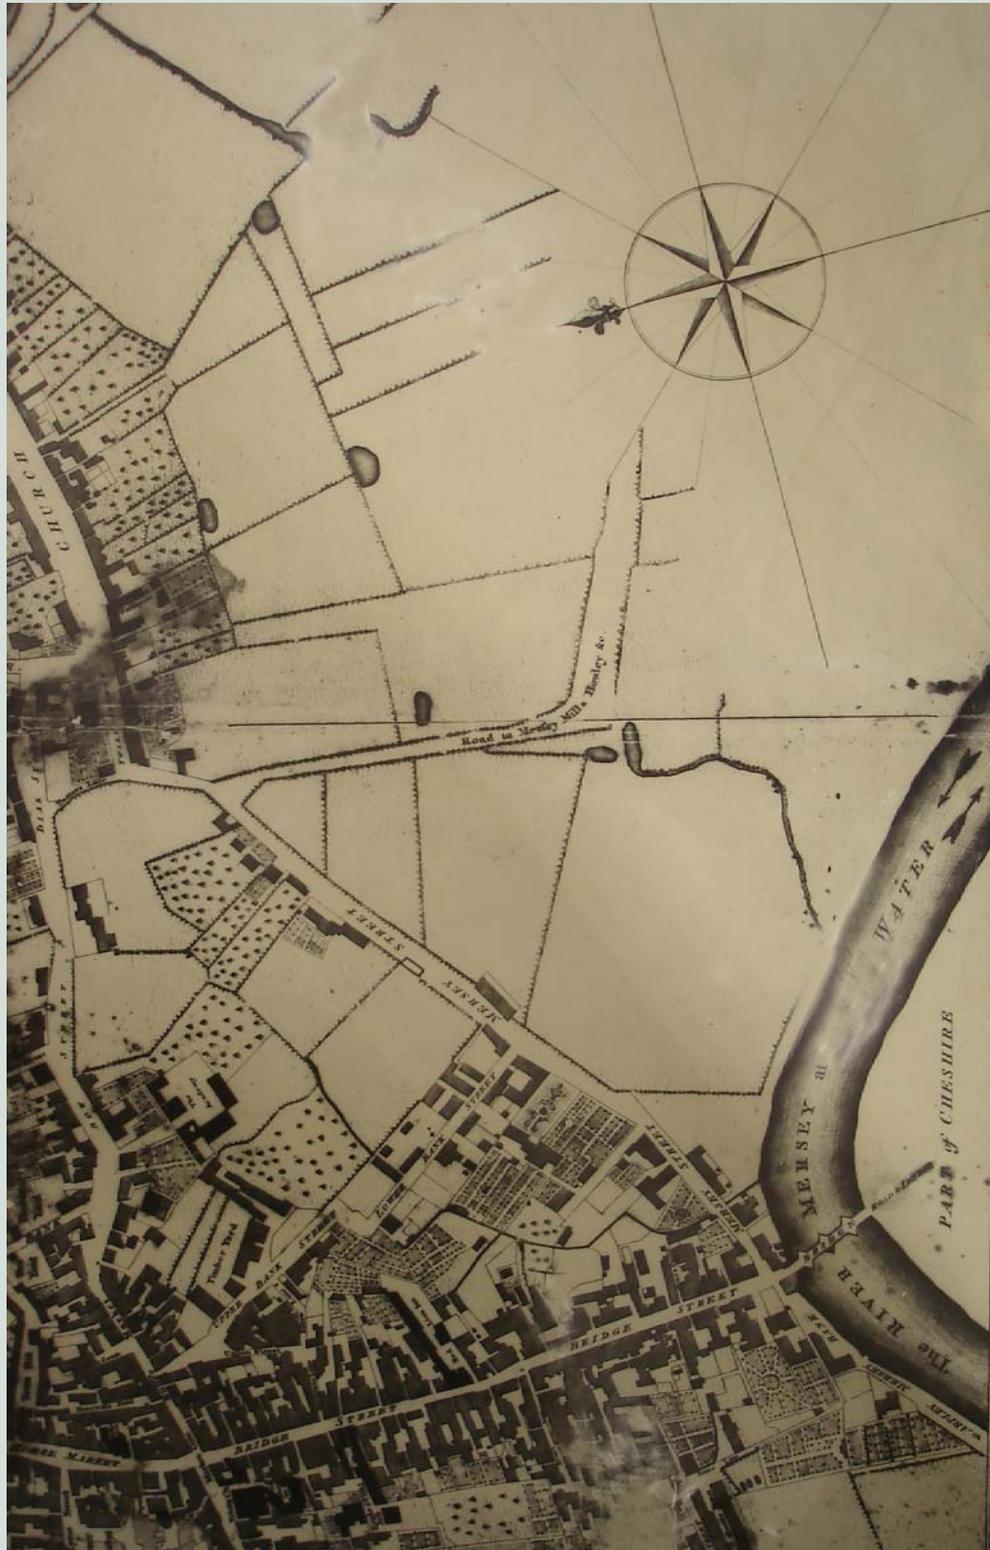
Fig.5 1772 map extract.

Activities recorded on the 1772 plan were tan yards and timber yards, the Warrington Academy. A Quakers Meeting House is not annotated at this date.

The earliest large scale map of Warrington by Walworth and Donbavand, 1772, reveals that Church Street was by then fully built up with frontage development in the form of narrow burgage plots. Building development extended along Buttermarket Street from Market Gate eastwards towards Church Street but there remained substantial gaps and to its south extensive orchards and pasture occupied much of the space up to Mersey Street. The very narrow inner part of the present street was named Butter Market. It continued eastwards widening, as Bow Street, perhaps because of its noticeable dogleg, then Dial Street. The connection between Dial Street and Church Street was not continuous but in the form of a square. The west side of the square was a path called Tooter's Lane and the south side leading into Church Street was called Twill Street. Fennel Street formed the eastern side. North of present Buttermarket Street lay enclosed pasture land and orchards.

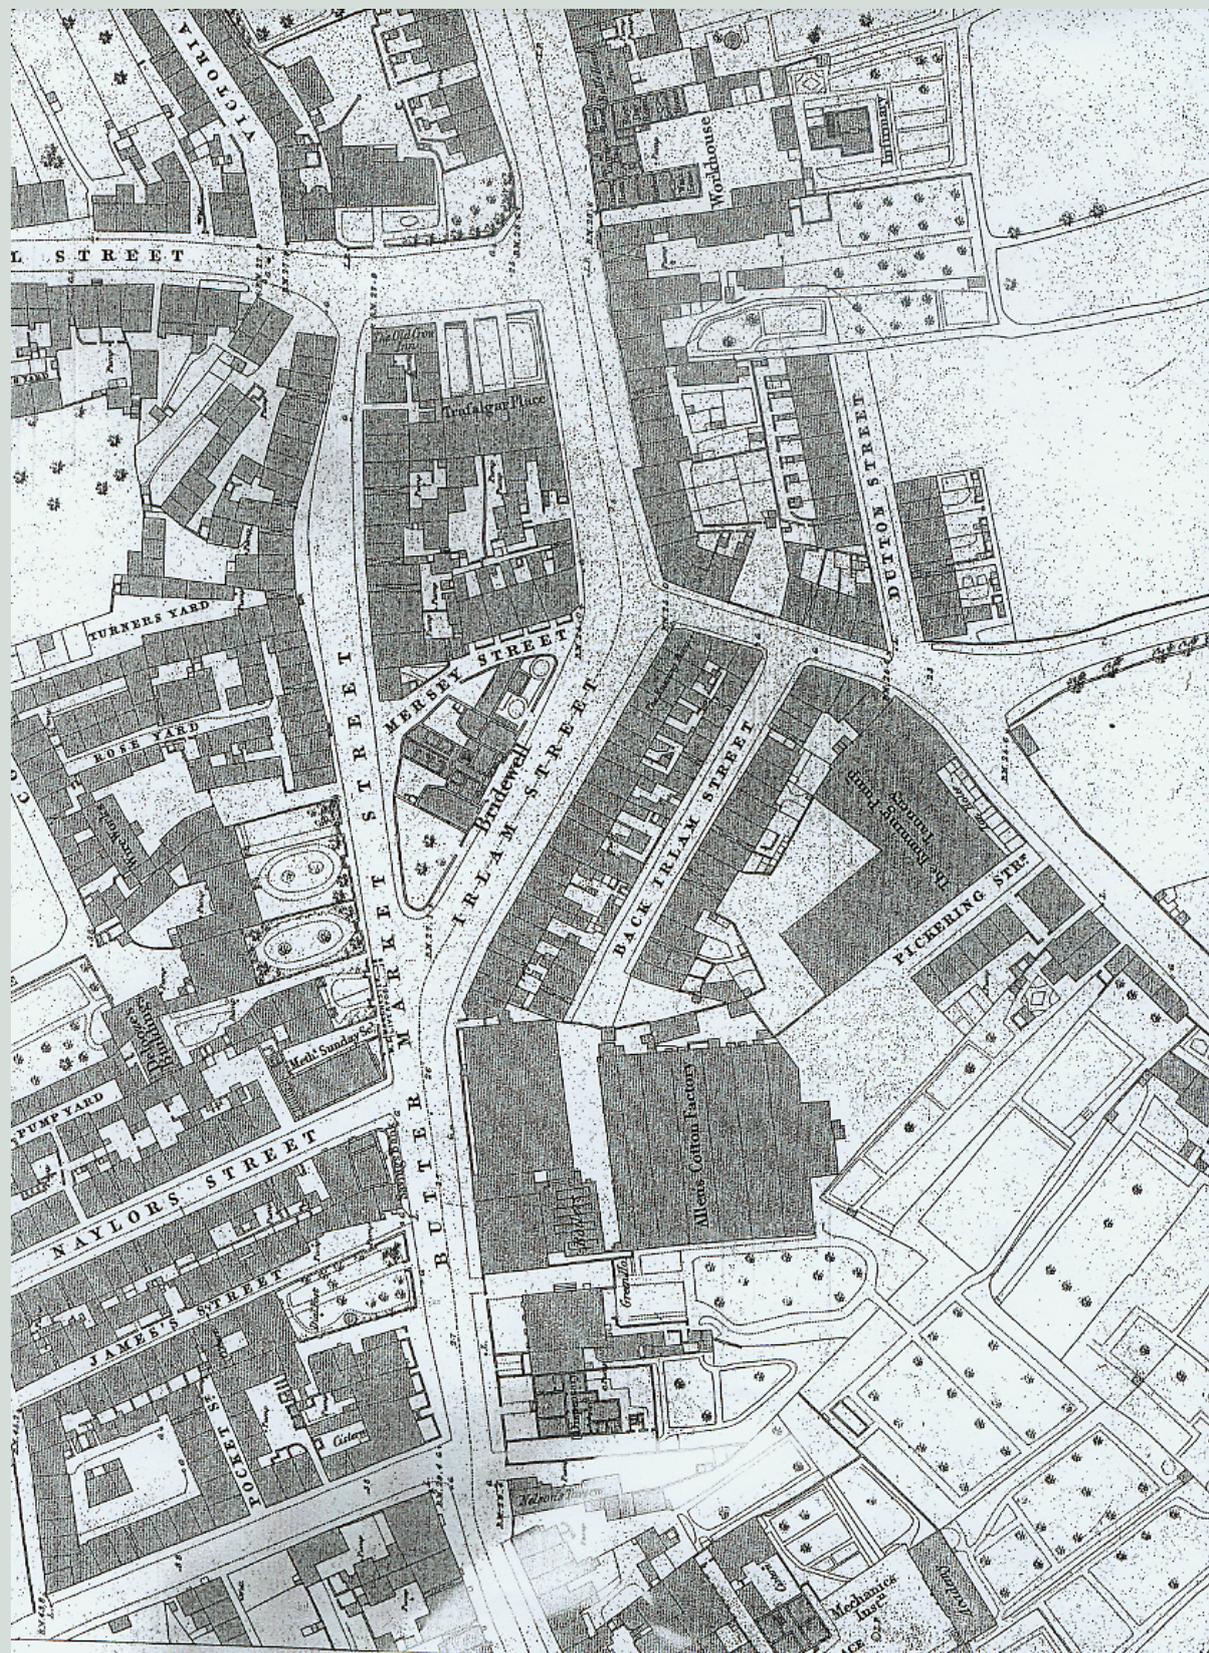
Figure 7 : 1851 Edition Ordnance Survey

The 1851 large scale Ordnance Survey, **Fig. 7**, shows that the historic frontages of Buttermarket Street which survive today, were in place. On the north side a dense pattern of workers cottages had appeared in terraced rows and courts. Cottages faced each other on James Street less than 4 metres apart! Behind no.95, aptly named 'Pocket Street', was a court of similar dimensions. Industries were now well established in this part of town including glass works, the renowned Stubs file manufactory, foundries and wireworks. South of Butter Market Street, Allen's cotton factory occupied the site later to be St. Mary's Church, beyond which was 'Running Pump Tannery', probably named after the ancient well or spring located between Church Street and Mersey Street.

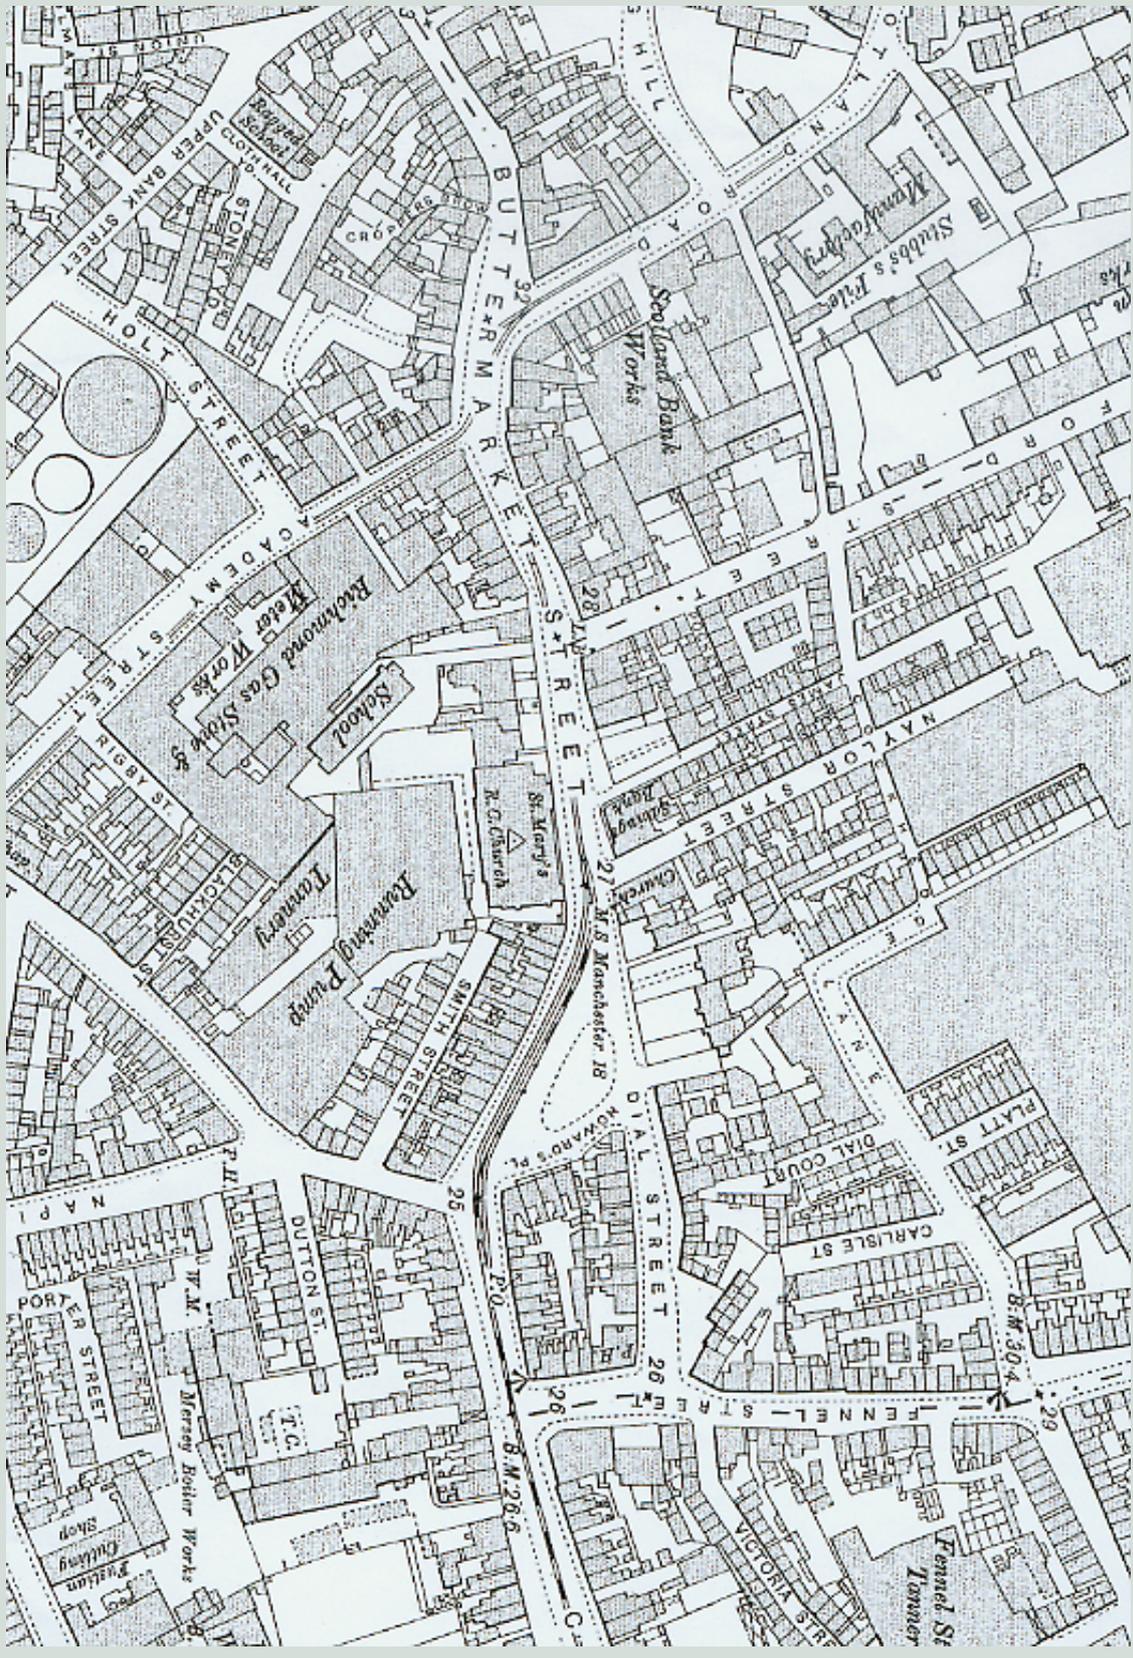
Figure 8 : 1909 Edition Ordnance Survey

A tramway ran along the street towards Church Street. The bridewell had gone, having functioned as the town prison from 1820 to 1900, when new premises on Arpley Street replaced it,- but ancient Tooter's Lane survived -this time as Howard's Place! Irlam Street was not named on the 1909 OS. The savings bank had been enlarged and the Church (no.101) remained in use.

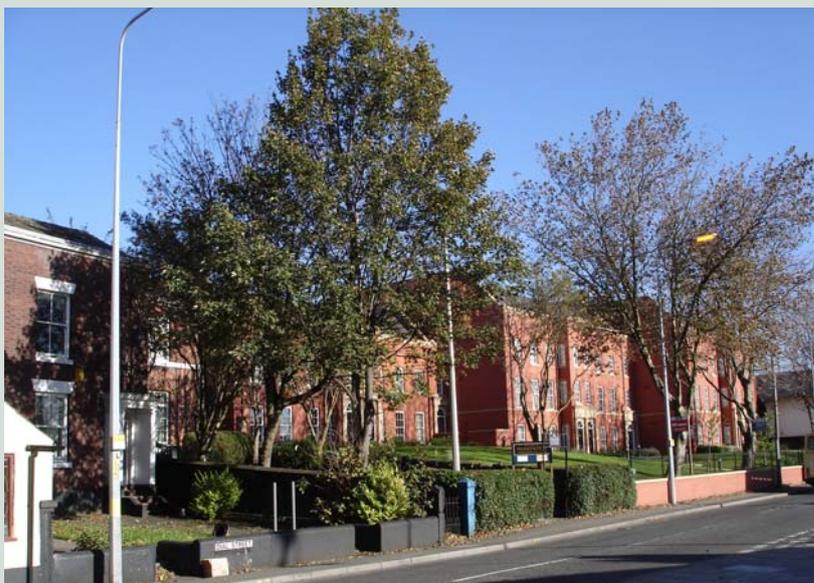
The development illustrates the sometimes long timescale required to achieve worthwhile improvements in the quality of the townscape. The majority of the site lay outside the existing conservation area boundary. However its impact on the conservation area was noted and a design of apartments considered appropriate to the location was achieved. The traditional form of building in a Georgian style was considered to respect and complement the building stock within the conservation area. The use of natural slate, good quality brick and good window details have all contributed towards the success of the site.

- Replacement of nos. 91,93 by the Creamer Insurance building. In scale and form this is a modest building though let down by its dull brown brickwork and flat roof.
- Demolition of the Victorian St.Mary’s School and replacement by offices of similar scale and sympathetic style.
- Demolition of the Catholic Social Club, Ashton Hall, and ultimate redevelopment by the Georgian style town houses. This can only be described as a positive change.

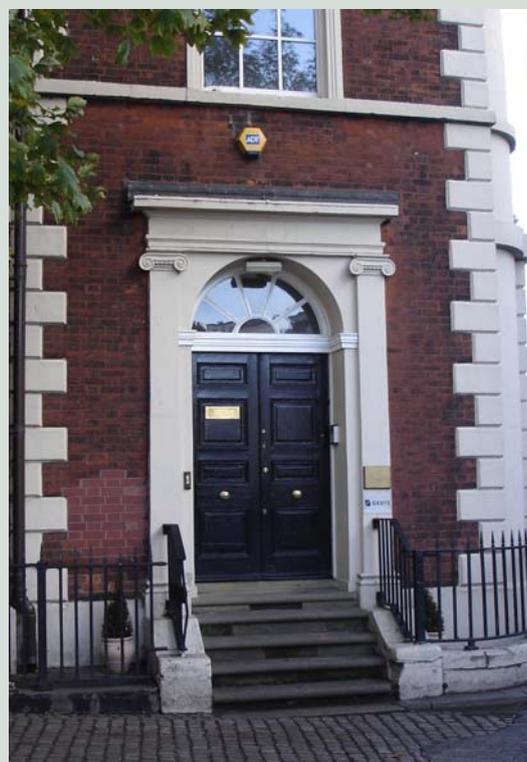
Its eastern boundary is formed by James Street, a narrow sett paved lane flanked by no. 101 now offices, formerly the Trustee savings Bank. Listed Grade II the main building is two storeys part three on its eastside. Its west elevation facing the garden of no 95 is in red brick with painted stone window surrounds, strings and quoins. The west door surround has Ionic pilasters and radial fanlight. The panelled double door is reached by 5 steps, flanked by low walls and railings. The front elevation is the more imposing, featuring rusticated painted stone ground floor with three round headed windows and porch with pilasters. The first floor is probably painted stucco. Ionic pilasters frame four twelve paned sashes; above is a frieze and cornice. The building shown on the site on the 1826 map did not extend up to Naylor Street. The 1851 OS annotates a building on the site as 'Savings Bank' but it does not coincide with the footprint of the present building. It would appear that a new facade was added after 1851 but the present building may perhaps incorporate elements of earlier structure.

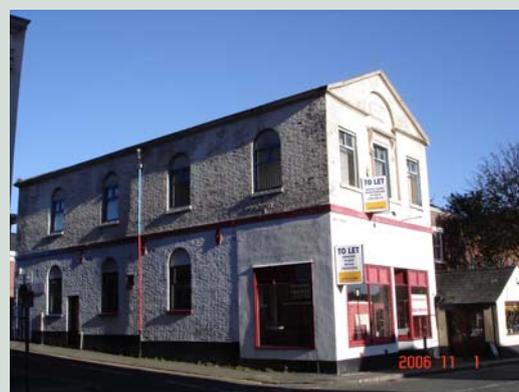
In contrast with the prestigious bank, the chapel like building with side wall to Naylor Street, is appropriately austere. It is two storeys, painted brick, gable end to the main road. The side elevations feature round headed windows to ground and first floors. Windows are modern as is the shopfront. The centre window of the south gable has a bracketed hood, above which is a plaque proclaiming 1817. The building is shown on the 1826 map as a Wesleyan Methodist Sunday School. Tie plates indicate some structural problems.

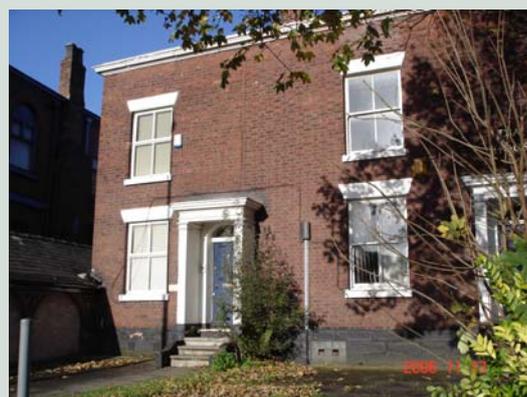
2 and 4 Dial Street, Bank House and Dial House, are a semi-detached pair of modest two storey houses facing onto front gardens of about 9m. They were constructed in local brick in Flemish bond and probably date from the first half of the C19th., their windows being of the 4 paned sash type rather than the multi-paned Georgian pattern. Despite their unpretentious style, attention has been paid to detailing in terms of the fanlights above the door and the wooden porches with panelled pilasters, frieze and cornice. No. 2 has received replacement windows which appear to be top hung rather than vertically sliding sashes.

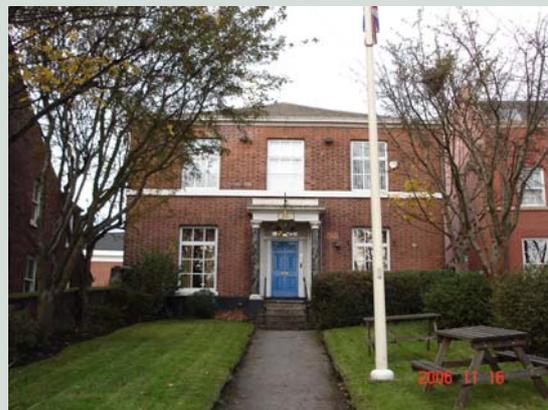
No 6 Vigo House is a larger detached house, two storeys, hipped roof and central portico with marble columns. It was the Regimental Club of the South Lancashire Regiment until 1971. A plaque over the iron gateway commemorates the association of Mrs Barbauld with the site in the C18th.

It would appear that the present building was in existence by 1826 and is possibly the building represented on the 1772 map. Regrettably all front windows are replacements.

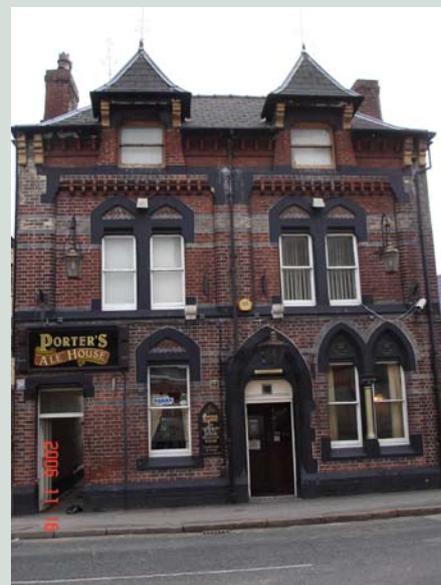
On the south side of the street, opposite Orford Street, Porter's Ale House, is a form of Gothic-revival town pub which faces defiantly onto New Town House. Two storeys plus twin attic gable windows with pyramid roofs and elaborate finials. Its frontage is less than 10m giving it a tall, narrow appearance. Its side gables are prominent because of the set back of adjacent buildings and carry large painted advertisements. Its original name 'Cross Keys' is perpetuated in stone relief logos above a pair of ground floor windows.

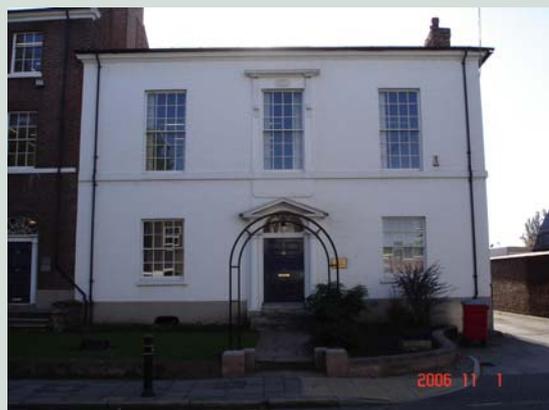
No 80-84 are a group of Georgian style town houses set in front gardens of about 7m. No 80 is two storeys but very high ceilings raise the eaves almost to the level of the 3 storied nos. 82,84 adjoining. No. 80 is painted brick, 3 bays, central pedimented doorway with Roman Doric columns and interlaced fanlight. It is shown as a dispensary on the maps of 1826 and 1851. The site was undeveloped in 1772, but it is described in the list entry as a late C18th house. Its large first floor windows have 24 paned sashes with fine glazing bars, the centre window with bracketed hood.

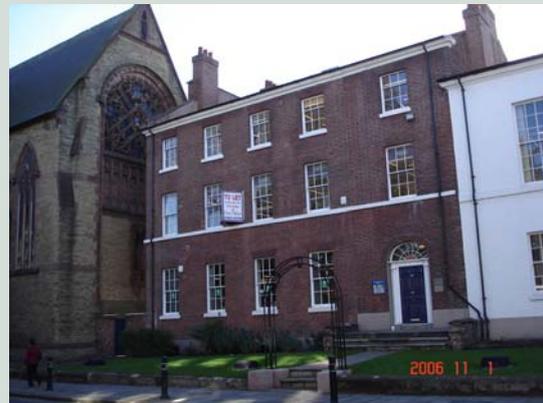
No 82-84 is now converted into one building; three storeys, unpainted red brown Flemish bond brick, stone cornice and string. Described as late C18th or early C19th. No 82 has an 8 panel door, fluted 3/4 Roman Doric columns and semi-circular fanlight. No 84 had its entrance on the east gable, now bricked up. It was shown as a Priory on the 1960s OS, linked to the adjacent St. Mary's Church. This group has been renovated to high standard and forms part of the Priory Court offices.

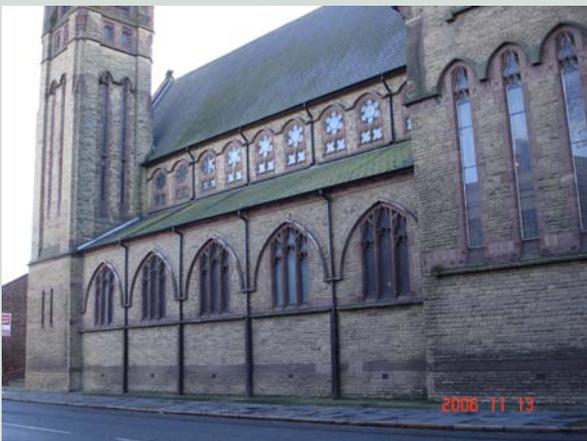
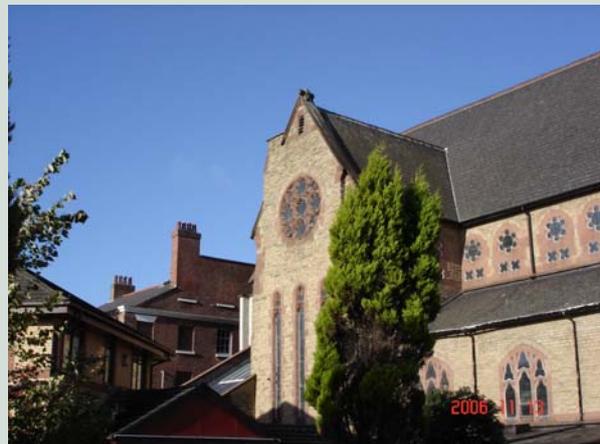
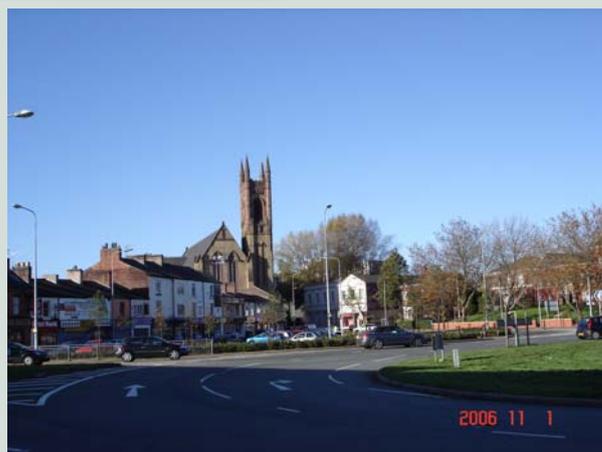
St. Mary's has been mentioned in section 4.1. With its contrasting pink and buff stone and rich Gothic Revival detailing, St. Mary's Church makes a very significant contribution to the overall character and appearance of the conservation area. The transept rose windows, the massive west circular traceried window and the rows of 'sexfoil' windows to the clerestory are especially notable. Its richly detailed interior with geometric tiled floor is every much as good as the exterior. The slender tower defines the eastern approach to the town centre and is one of the town centre's major landmarks, visible from the approach to the town at Bridgefoot, and from along Mersey Street. The views into the conservation area and the church tower should be retained and protected. It is notable that the cramped site resulted in the street entrance being via a narrow passage at the eastern end. Two east doors provide access to the interior; a large nave door and a minor door to the south aisle, the altar being situated at the west end.

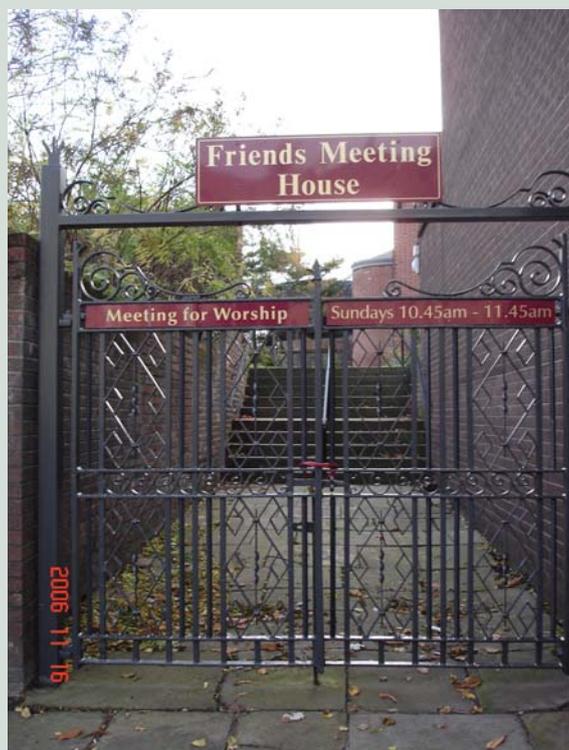
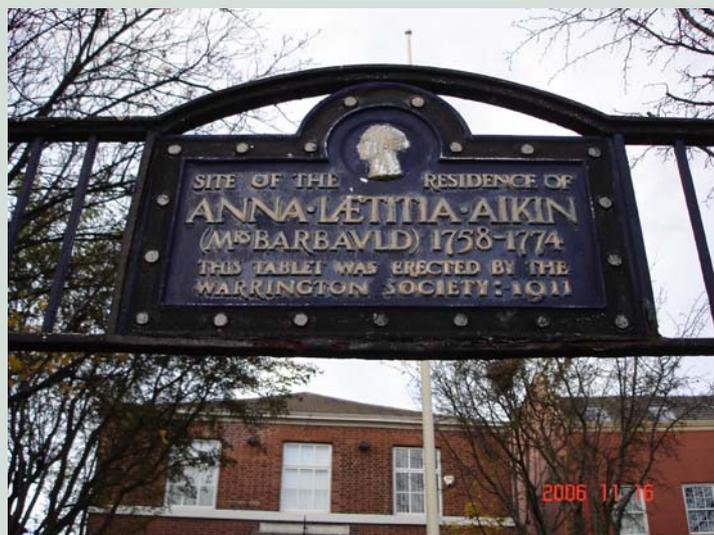
The buff regular coursed rubble used for St. Mary’s Church is not locally sourced but the pink sandstone is typical of the local sandstone outcrops which occur in Merseyside and north Cheshire. As in other conservation areas, there has been a loss of ironwork due largely to the war effort. Surviving traditional ironwork is therefore all the more important in enriching the street scene and should be preserved. Equally, modern variants can contribute to detail interest. Examples in Buttermarket Street are the railings in James Street and the ornamental gateway to Vigo House with commemorative plaque and the gates to the Friends Meeting House. A modern iron-work arch has been installed as a form of gateway in front of no 80 with good effect. Where old cast iron street nameplates survive as in Naylor Street, they should be retained in situ.

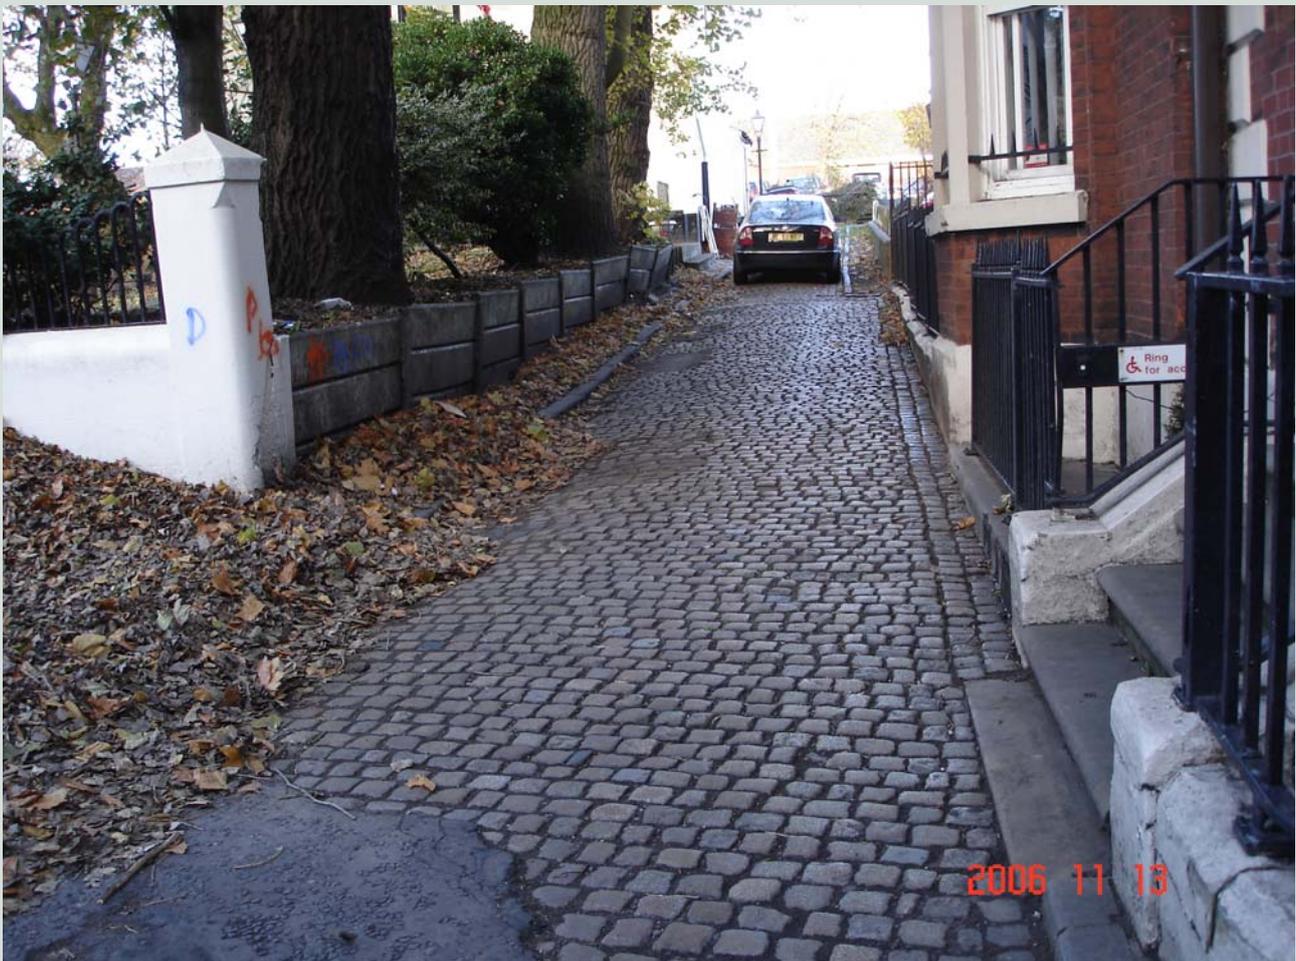
Elsewhere, footways are a mixture of concrete flags and tarmac. In places, the flags are broken and displaced and the tarmac patched.

Street furniture however makes little concession to the conservation area. Traffic signs proliferate. Lighting columns are standard 'hockey stick' types. Most poles are galvanised or grey. The galvanised guard railings around the junction with Academy Way, Scotland Road, further detract. However the newly landscaped area at Dial Street provides a pleasing foreground to the historic buildings and will gain in presence as the tree canopies develop.

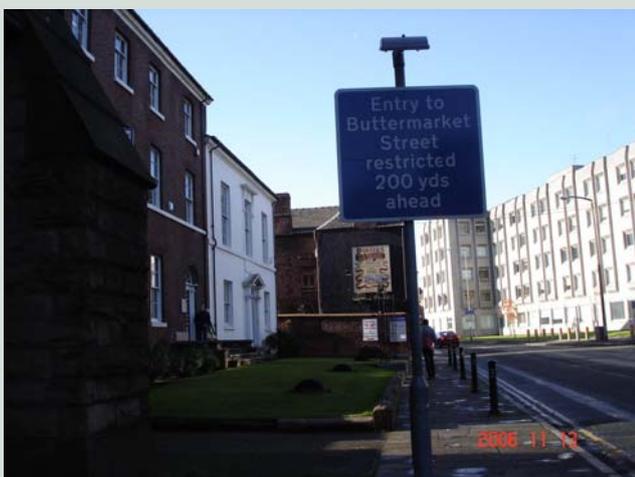
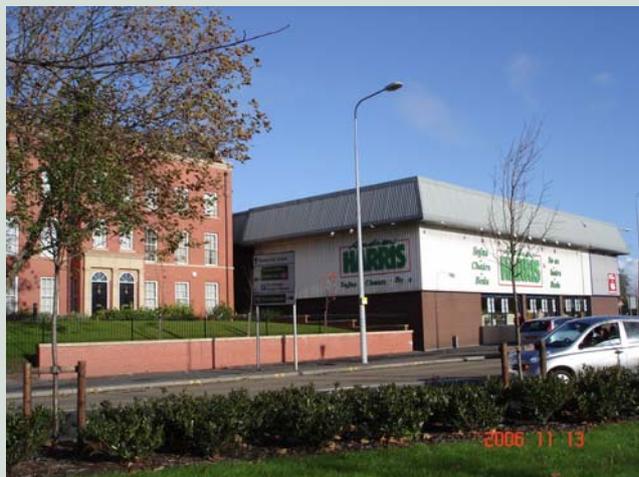
- \* New Town House with its grey concrete cladding which emphasises its ungainly form and bulk. From a distance the array of antennae on its roof is visually intrusive as are the wooden bollards with fluorescent strips at the back of footway.
- \* The retail warehouse at Fennel Street/ Dial Street now seems incongruous in relation to the modern town house development, partly by reason of its cladding and signage.

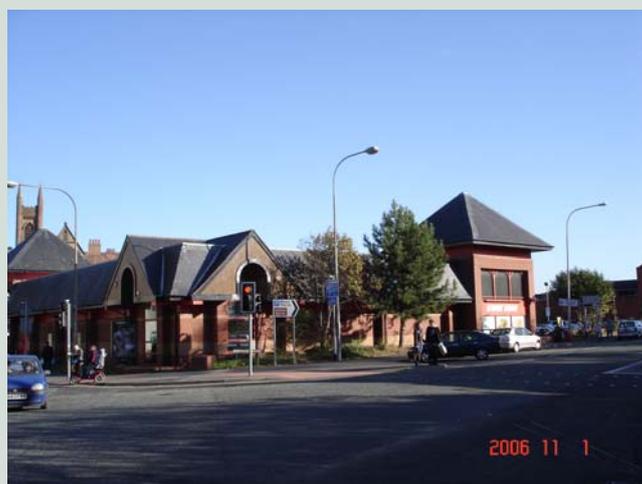
\* Kwik Save tries to reflect some local themes but its single storey height is inappropriate to the prominent corner site and in plan form it fails to respond to the scale and proportions of the neighbouring historic structures. It presents a blank frontage to Buttermarket Street.

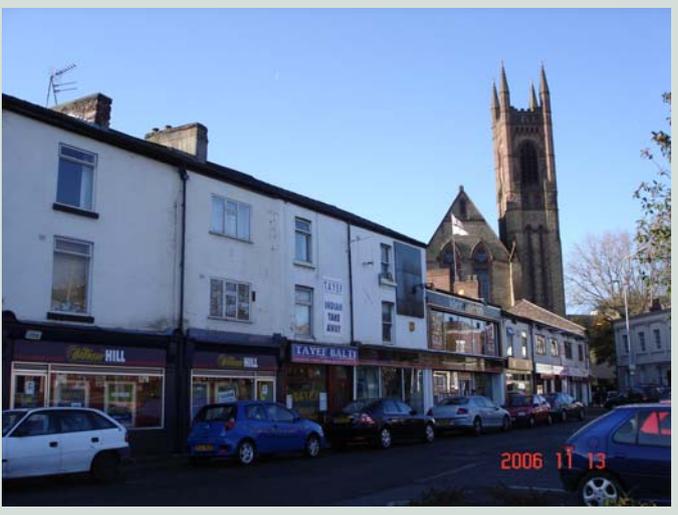
\* The shop unit at Academy displays excessive signage in relation to its small size.

\* Generally poor presentation of the row of shops no. 86 -118. William Hill has a restrained shopfront but the others suffer from an excess of signage, some of which is extremely tawdry. The taxi office is virtually covered in banner advertising. Many including the take-aways, which are closed during day time, have roller shutters. At the rear is an ugly conglomeration of extensions, additions, pipes and wires.  
*(Judging by the survival of some original elevational detail, the basic buildings are however almost certainly those facing Irlam Street indicated on the 1851 OS).*

- \* However, the terrace of shops at 86 - 118 Buttermarket Street, though outside the conservation area, has suffered from a variety of detrimental alterations. Most buildings in the row have lost original details at first floor level. A particular modern trend that is a cause of concern is the alteration of original window openings, where new window frames extend beyond the obvious structural window heads, such as; 90-94 Buttermarket Street, 98-100 Buttermarket Street, 110 Buttermarket Street.

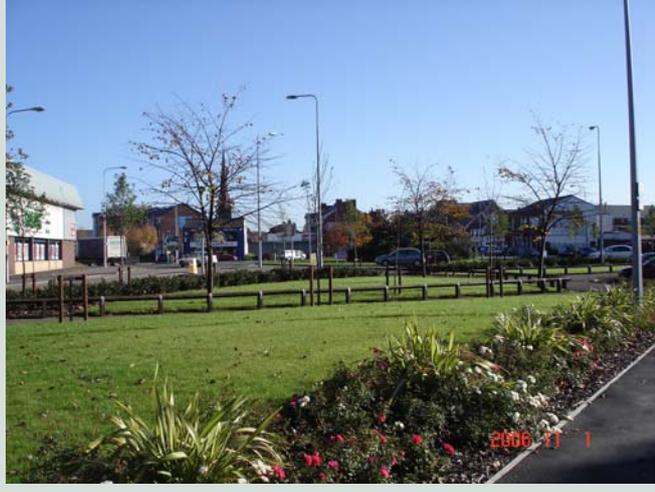
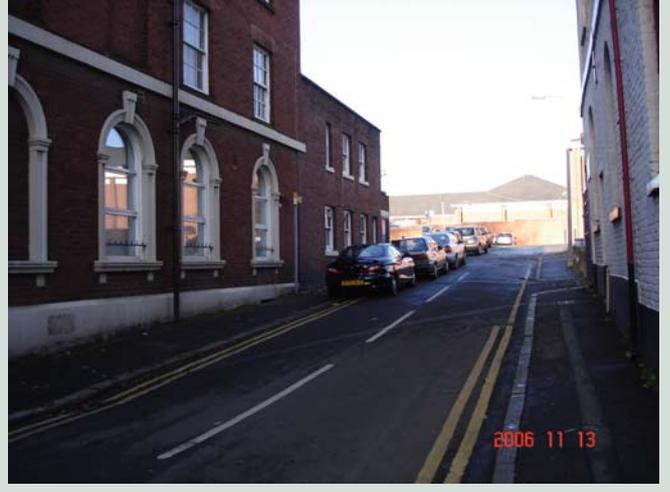
\* Space leakage- i.e. loss of enclosure at the eastern extremity caused by the wide traffic intersection and low profile buildings beyond; also in views northward along Orford Street James Street and Naylor Street.

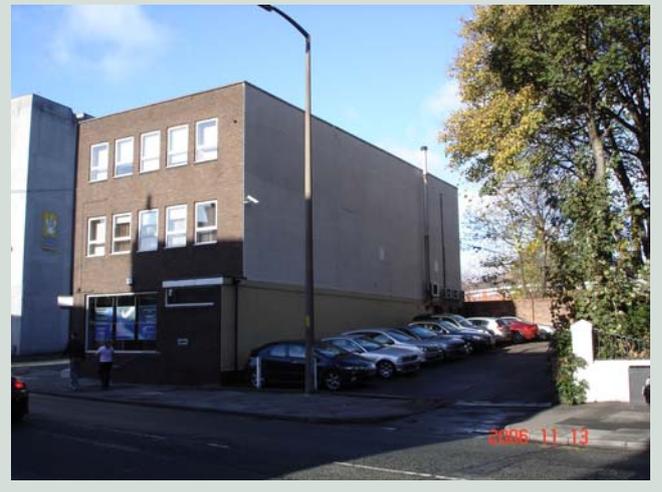
\* The car park adjacent no.93 is open to the street and exposes the rendered gable wall of the modern building with flue pipe and air conditioning units. The rendered wall suggests an original intention to extend.

- \* Site adjacent to no.93 ( Creamer Offices) - an infill site which would restore lost built form and contribute to the enclosure at this point
- \* Car parks at the rear of no. 97 and no 101.
- \* The retail warehouses at the corner of Dial Street/Fennel Street.

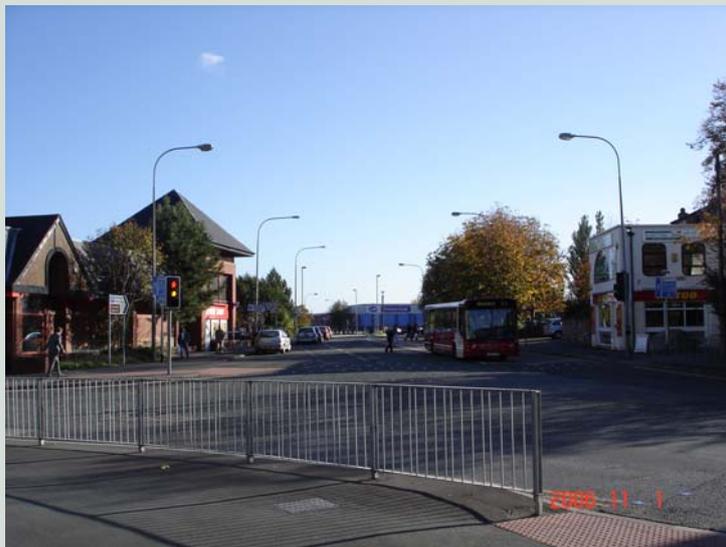
- \* The numerous traffic lights and galvanised barriers at the junction of Buttermarket Street, Academy Street and Scotland Road, are visually intrusive, though essential for highway safety. However the impact of the barriers could have been reduced by painting them black or by use of a more traditional design. The railings adjacent to 'Yates' are painted black and are visually less intrusive than the galvanised barriers.

- \* Tree planting in the space at the south-west corner of New Town House would help to diminish the visual impact of the highway furniture.

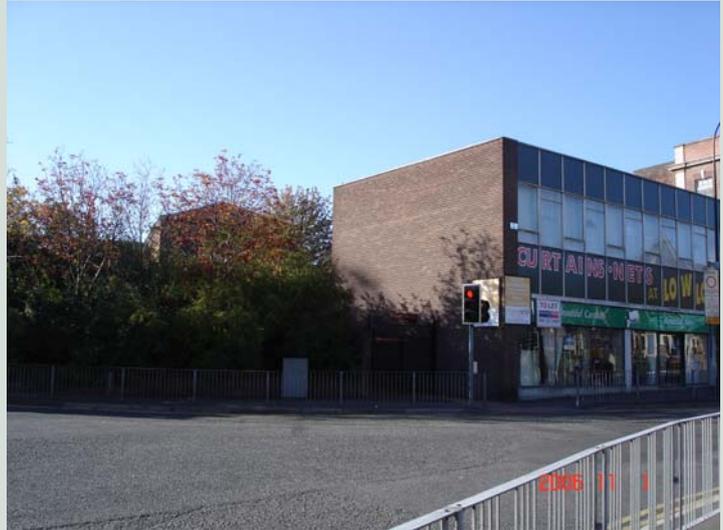
- \* Nos 50-54 adjacent to the Friends Meeting House- a bland modern building on a prominent corner position which has the potential as a town centre gateway site
