Western Link

Ground Investigation Report

Document reference: 382900-WL-MMD-07-ZZ-RP-N-0002

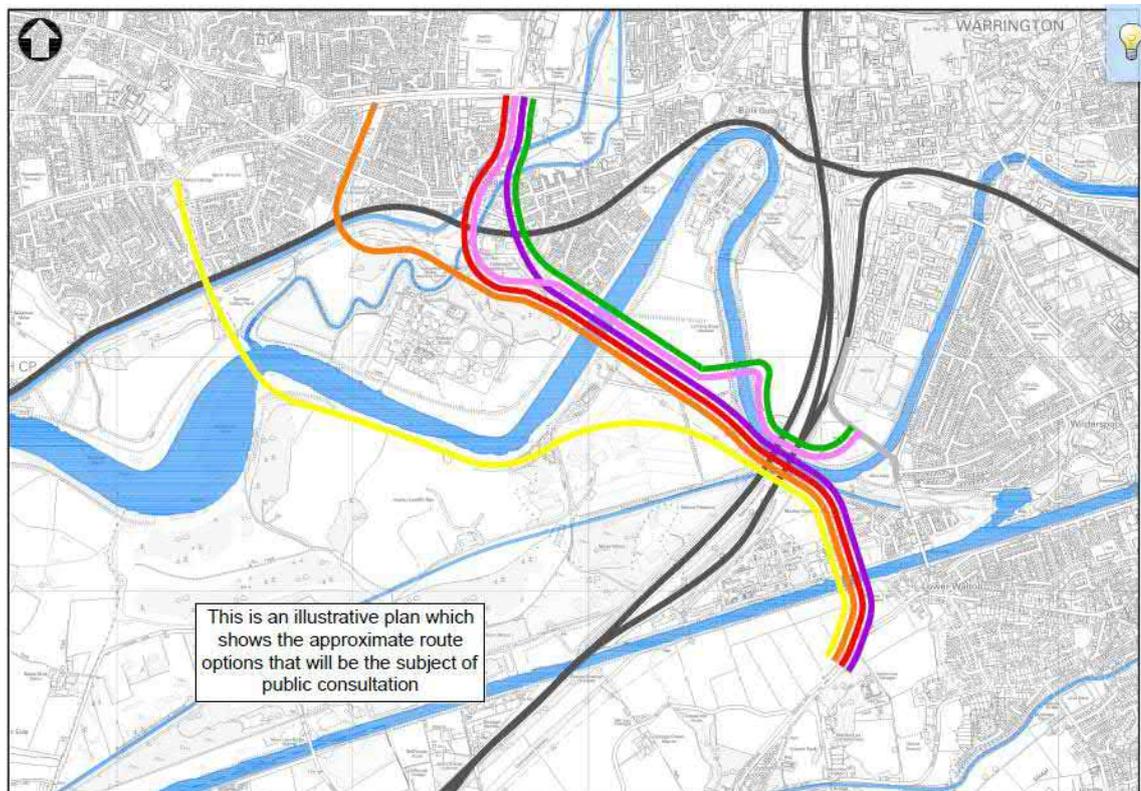
Figure 1: Phase 2A Routes

1.2.5 A Stage 1 preliminary sift stage has been undertaken which reduced route options under consideration at Stage 2 sift from 65 to 6. This GIR focuses on the Stage 2 sift options which are detailed in Figure 1 and provided in greater detail in Appendix B. Routes are colour coded for the sift process.

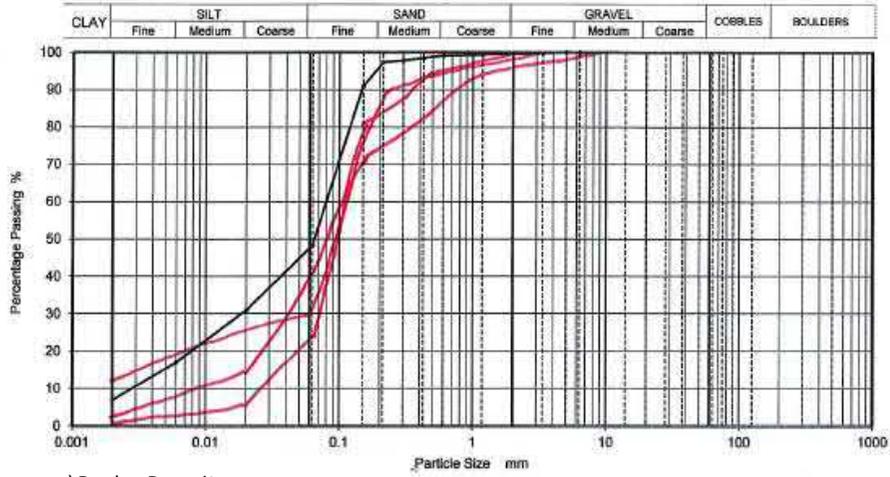
a) Dredge Deposits

Figure A.3: Grading curves

- 5.3.2 PSD curves prepared from specimens of sand sampled from the dredge deposits describe a silty fine sand or silty fine to medium sand (Figure A.3a). Relative density derived from CPT soundings through this material typically varies between 15 and 25%, representative of loose deposits. The silt horizons encountered in the Dredge Deposits generally classify as intermediate plasticity (MI) (Figure A.2). The internal angle of friction of the sand as derived from CPT soundings (CPT14 and CPT15) varies between 30 and 35 degrees.

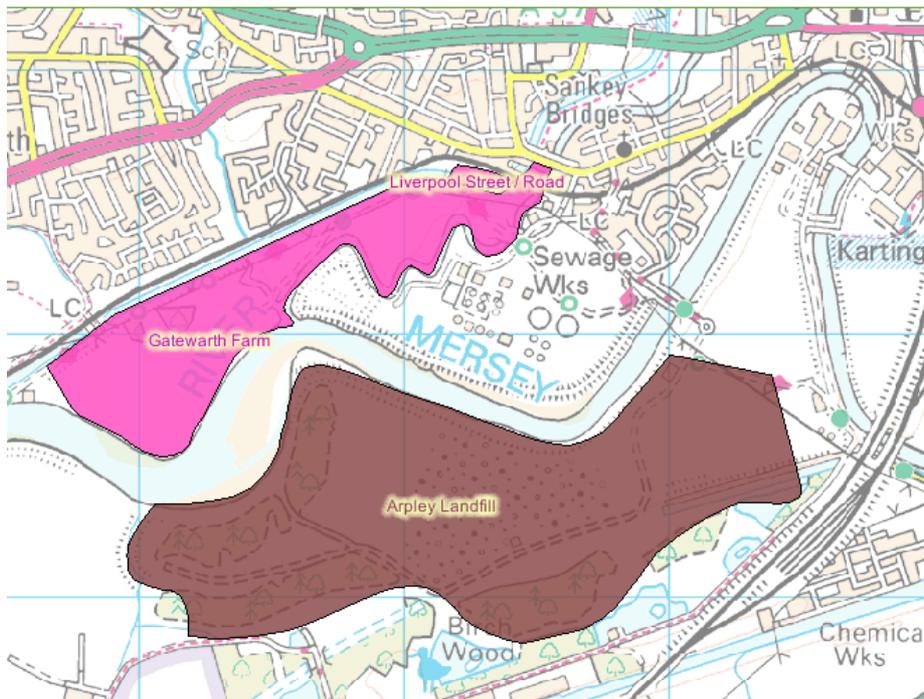
Figure 1 Location and boundary of Gatewarth Farm and Arpley Landfill (image source Environment Agency website, 2017).

As part of the Western Link Stage 2 route option assessment, Mott MacDonald have undertaken a review of existing, publicly available electronic data files held by Warrington Borough Council (WBC) for Arpley Landfill Site and Gatewarth Farm Landfill site, shown in Figure 1 below.

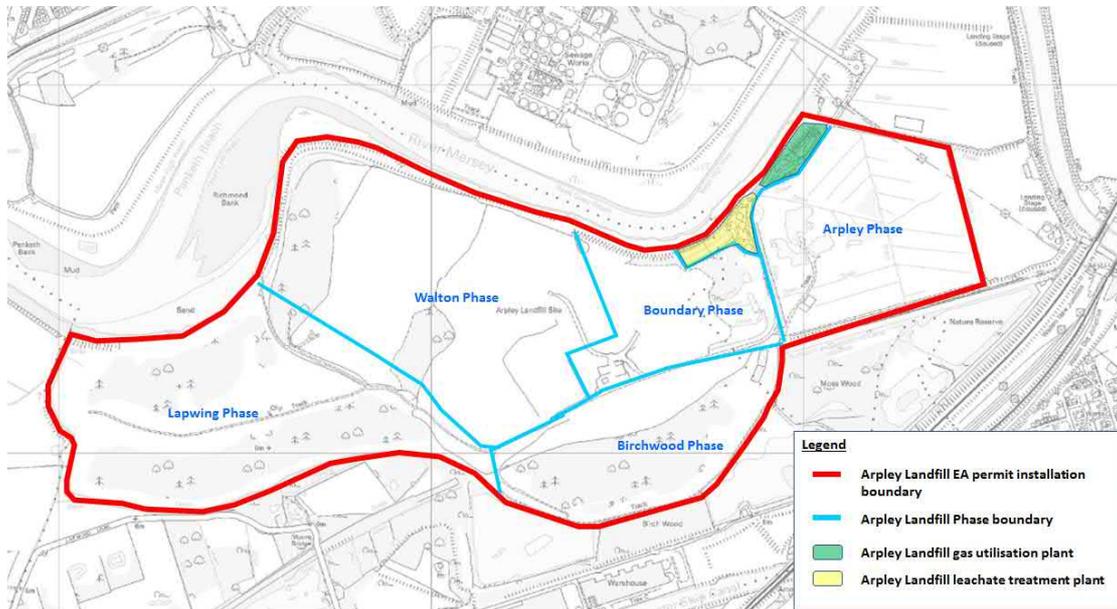
Figure 2 Arpley Landfill Phase boundaries (source: Golder Associates, 2010) and EA permit installation boundary (EA permit no. ref EPR/BS7668IH).

Details regarding the cell lining system and capping layers within Arpley Landfill are included within the Golder Associates Arpley Gas Risk Assessment, Report No. 09514290329/A.0, dated February 2010.

The Golder Associates report describes temporary and permanent capping will be applied in a progressive manner across the site. The permanent cap and gas collection systems have been (and are to be installed), the year following final waste placement. The permanent cap on all cells will likely comprise a single membrane liner consisting of 0.5mm HDPE (Birchwood, Lapwing and parts of Walton Phase) or 1mm LLDPE geomembrane (part of Walton, Boundary and Arpley Phases).

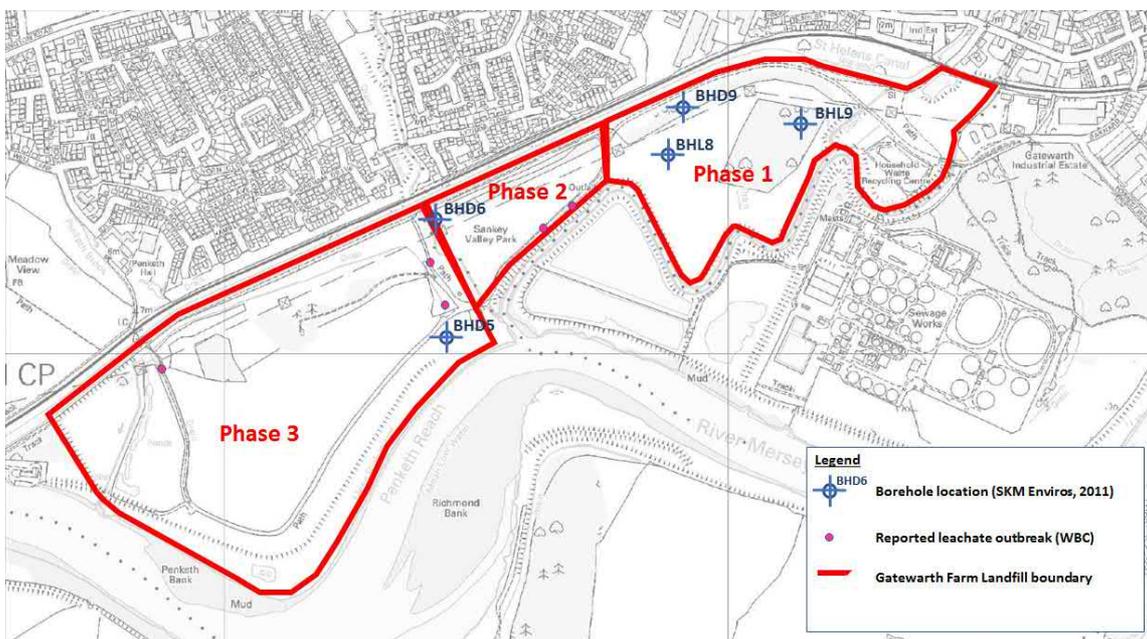
Figure 3: Gatewarth Landfill Phase location boundaries, WBC recorded leachate outbreak locations and approx. position of relevant borehole locations.

Leachate outbreaks have been identified in Phases 2 & 3, along the perimeter of the landfill, via overspill from the containment bunds, through underlying soils, overland flow and migration into groundwater. The leachate outbreaks have resulted in closure of the public footpaths on several occasions. The leachate was found to contain elevated concentrations of arsenic, lead and PAHs. From 1997 elevated levels of ammonia, chloride, cadmium, sodium and phenol have been recorded.
