Langtree PP and Panattoni

Six 56 Warrington

Addendum to Environmental Statement

Part 2 – Cultural Heritage & Archaeology

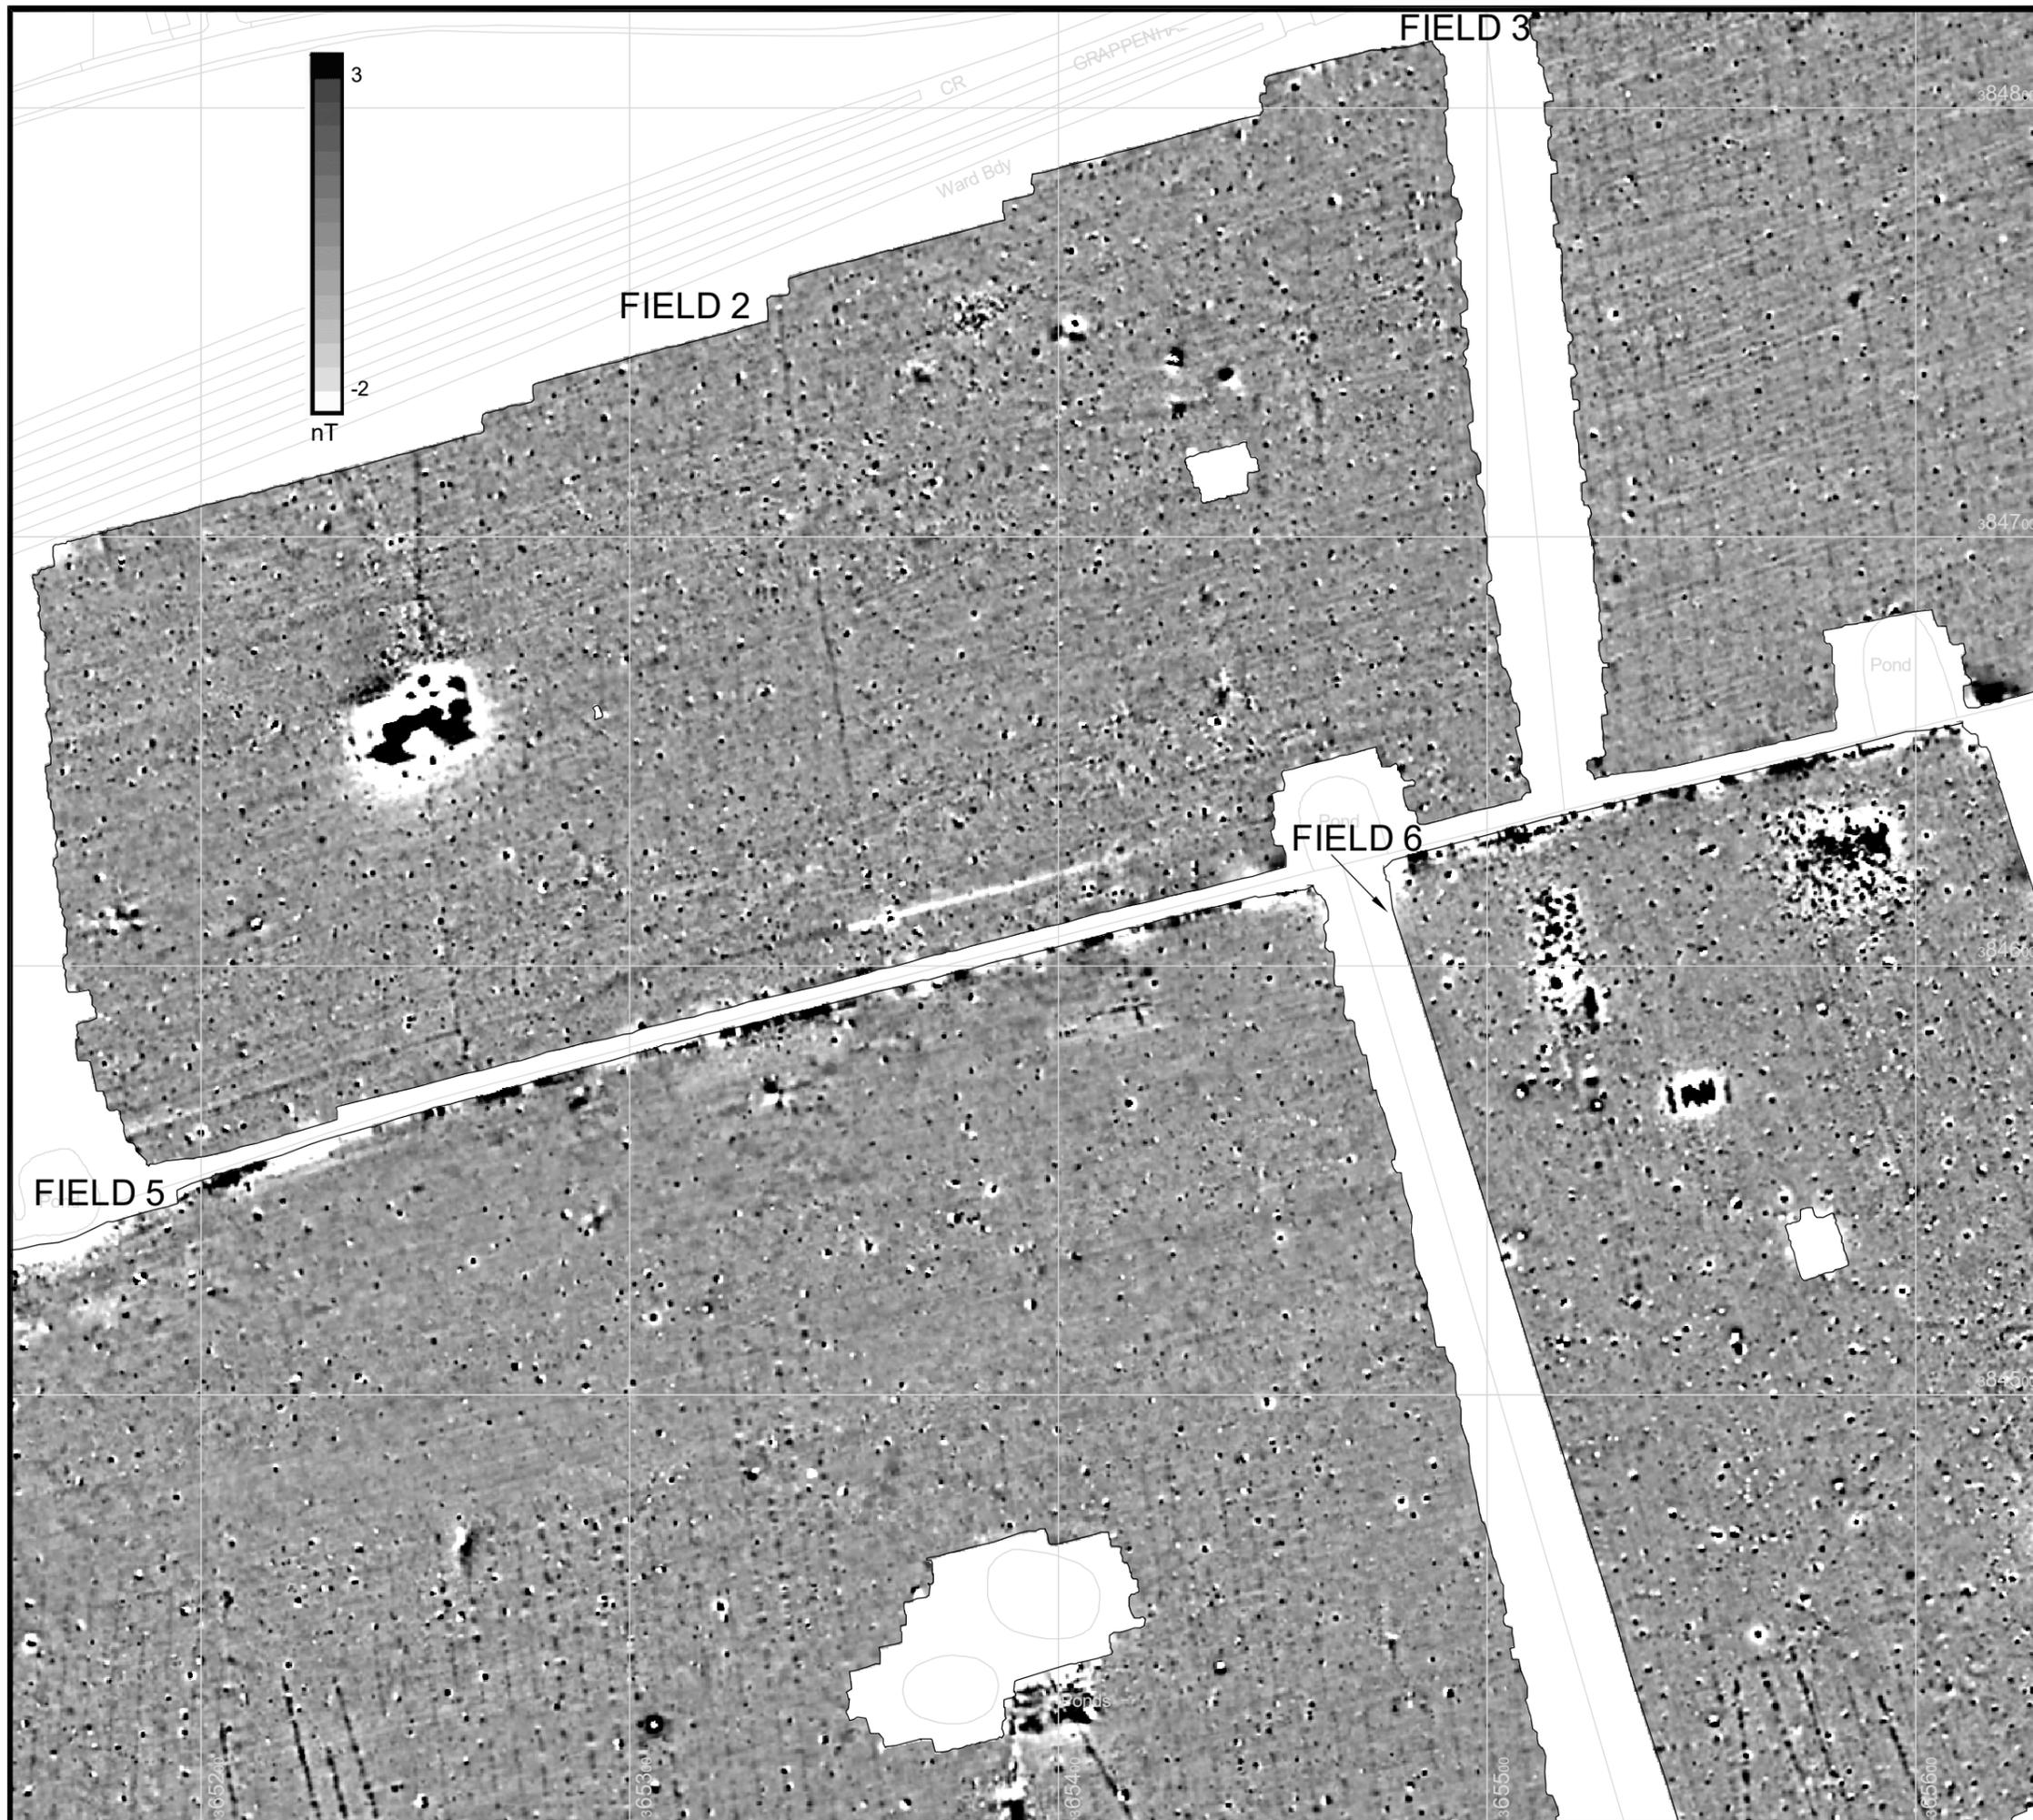
LINEAR POSITIVE OR BIPOLAR RESPONSE / TREND	BROADLY CORRESPONDS WITH FORMER FIELD BOUNDARY. RESPONSES WILL PROBABLY BE RELATED TO THIS FEATURE
LINEAR / CURVI-LINEAR TREND (WEAK OR DIFFUSE RESPONSE)	UNCERTAIN ORIGIN. POSSIBLE NATURAL FEATURE / VARIATION
LINEAR / CURVI-LINEAR TREND (WEAK OR DIFFUSE RESPONSE)	UNCERTAIN ORIGIN. POSSIBLE SUB-SURFACE FEATURE / REMNANT OF FEATURE
ISOLATED POSITIVE RESPONSE	PROBABLE GEOLOGICAL / PEDOLOGICAL VARIATION BUT COULD ALSO BE DEEPER BURIED FERROUS / FIRED MATERIAL OR INFILLED ISOLATED FEATURE
LINEAR / CURVI-LINEAR POSITIVE RESPONSE	POSSIBLE AGRICULTURAL FEATURE BUT COULD ALSO BE FIELD DRAIN OR INFILLED LINEAR / CURVI-LINEAR FEATURE

Scale	[A3 Sheet] 1:1500	Drawing	ARC_2247_857_04	Status	FINAL
Client	BWB CONSULTING LTD LEEDS				
Site	GRAPPENHALL LANE, GRAPPENHALL WARRINGTON, CHESHIRE				
Title	INTERPRETATION OF MAGNETIC GRADIENT DATA: FIELD 1, WESTERN PART OF FIELD 5				
Job No	ARC_2247_857				
Surveyed	JW, AB, CA	Drawn	JW, CA		
Chk.	NF, MW	Date	19/09/2018

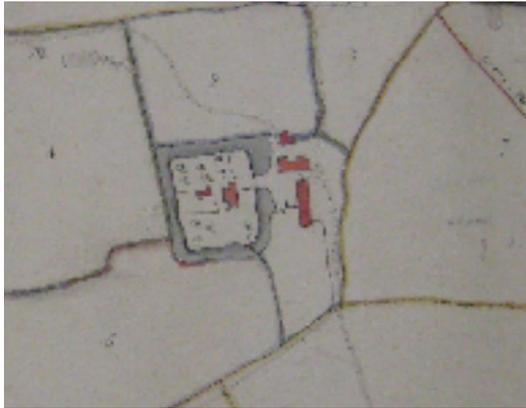
Inset 1 1820 Map of Cheshire showing first phase of Bradley Hall Farm

This courtyard arrangement was formed by extensions to the original early 19th century buildings shown on the 1820 Map of Cheshire (Inset 1) and the 1847 Tithe Map (inset 2).

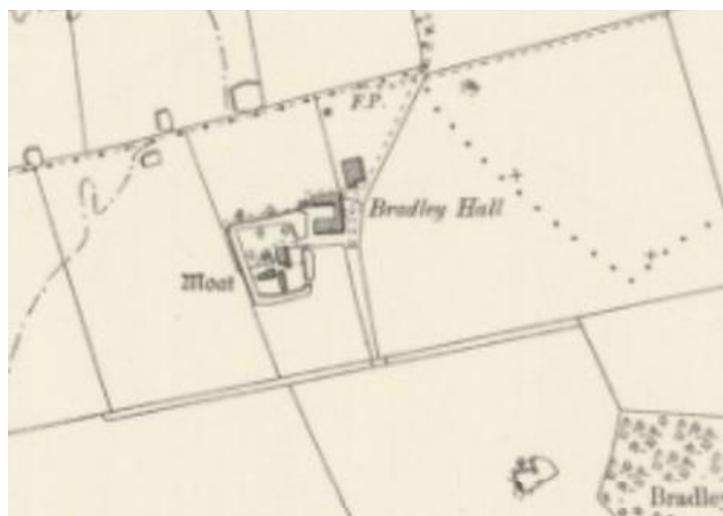
Insert 3 1899 Ordnance Survey map

the courtyard structure with central arched opening on its east side and lean-to structures on its northern arm. Smaller ancillary structures are also evident to the east and to the northeast, with the latter being the larger of the two. These structures did not last very long as in the late 1890s the larger one was replaced with a larger building and the other one demolished as shown on the 1899 edition (see insert 3)

This coincides with some re-modelling of the courtyard buildings, some infilling on the southern annex, the addition of a small lean to structure on the southern western tip of the lower courtyard range and the erection of a small rectangular building immediately to the west of the west side of the northern courtyard range. These changes are also shown on the 1910 Ordnance Survey map.

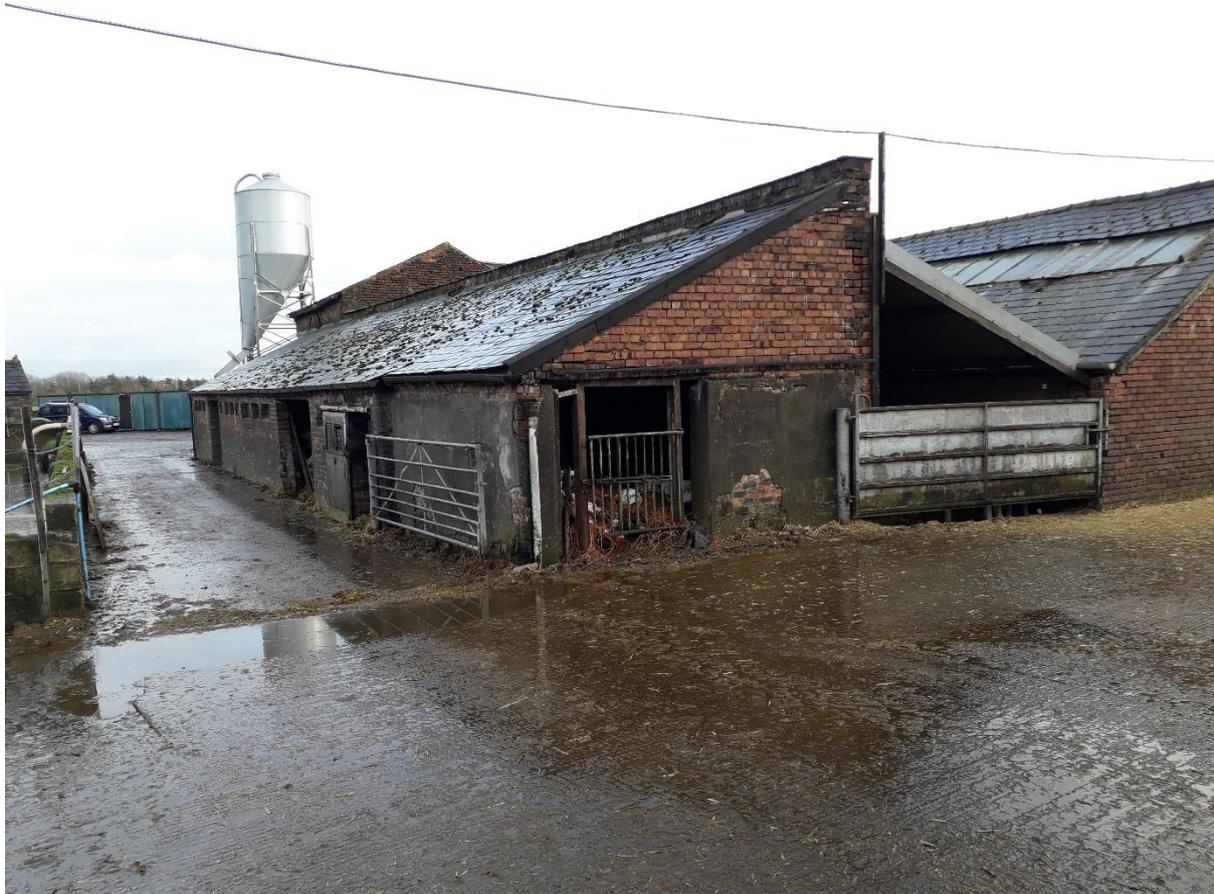
but the northern range has been demolished bar the outer northern wall. This occurred between 1910 and the late 1960s as evident from historic maps. A lean to mono pitch structure was built on the north face of the surviving north range wall, with evidence for where it was tied in clearly visible (Plate 1).

Plate 1 shows 20th century lean to added to outer wall of former northern range

- 5.61. The southern building range represents the first phase of building activity associated with the farm and was the precursor to the later courtyard arrangement. This comprised the addition of the eastern and northern range sometime between 1847 and 1877 as determined from the analysis of historic maps. It is noted that these ranges use handmade bricks, perhaps suggesting the re-use of material from a demolished structure, the candidate for which is the large building shown on the 1820 Cheshire Plan but demolished by the time the 1847 Tithe map was published. From the site visit, it is clear that both the southern and connected eastern range still survive but the northern range has been demolished bar the outer northern wall. This occurred between 1910 and the late 1960s as evident from historic maps. A lean to mono pitch structure was built on the north face of the surviving north range wall, with evidence for where it was tied in clearly visible.

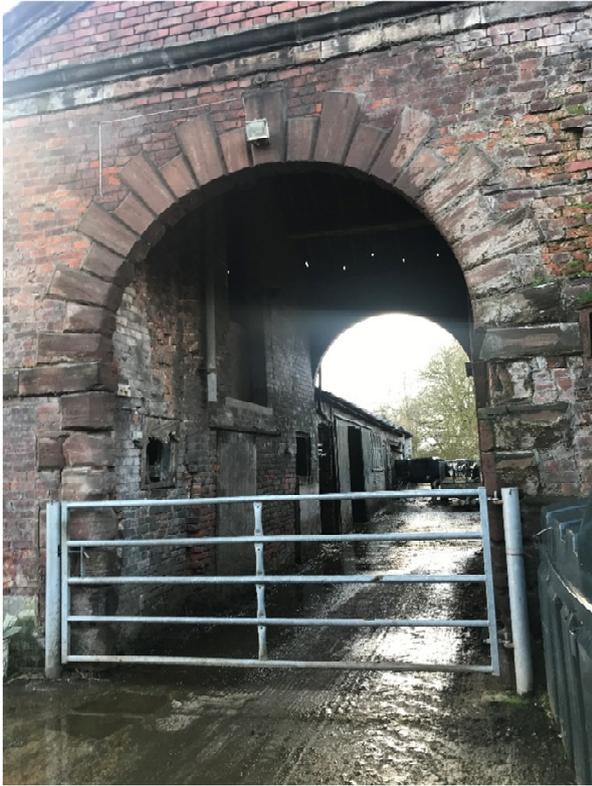
Figure 1: View to central arch of barn

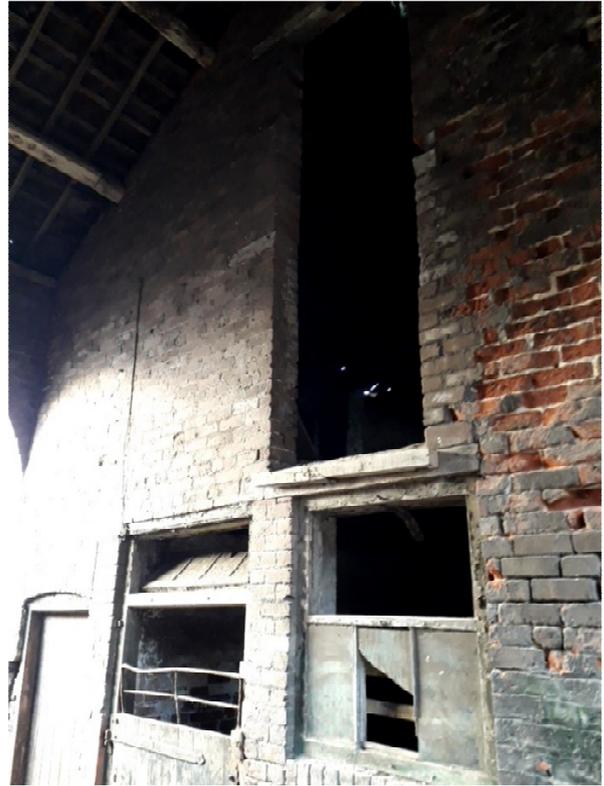
Similar defects are evident within the arch, particularly to the left-hand wall, and extensive areas of the wall would need rebuilding / repair to address issues of spalled facing (see Figure 2), and to more sympathetically restore previous modifications and bring back to a structurally stable condition. There were also signs of more significant structural defects including significant vertical cracking (see Figure 3 and 4).

Figure 2: Extensive loss of masonry face to entrance

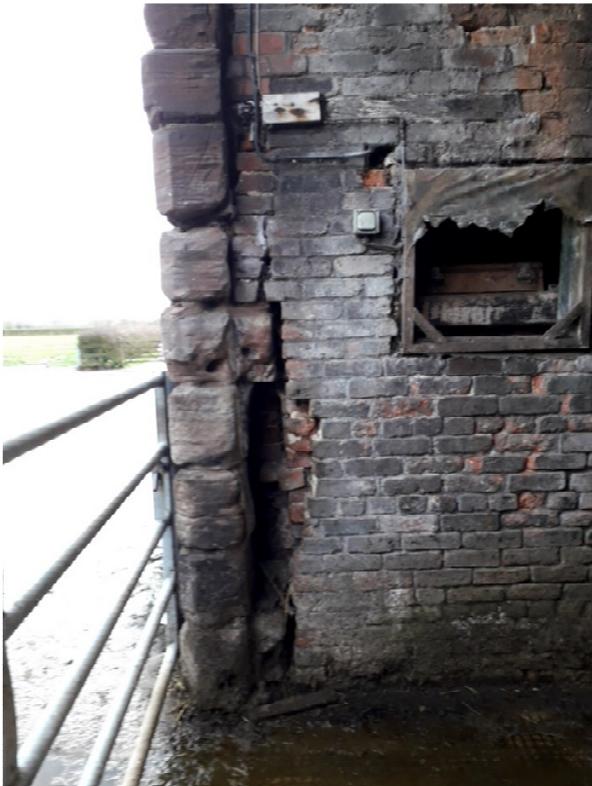
Figure 2: Vertical cracking and separation to rear of entry arch

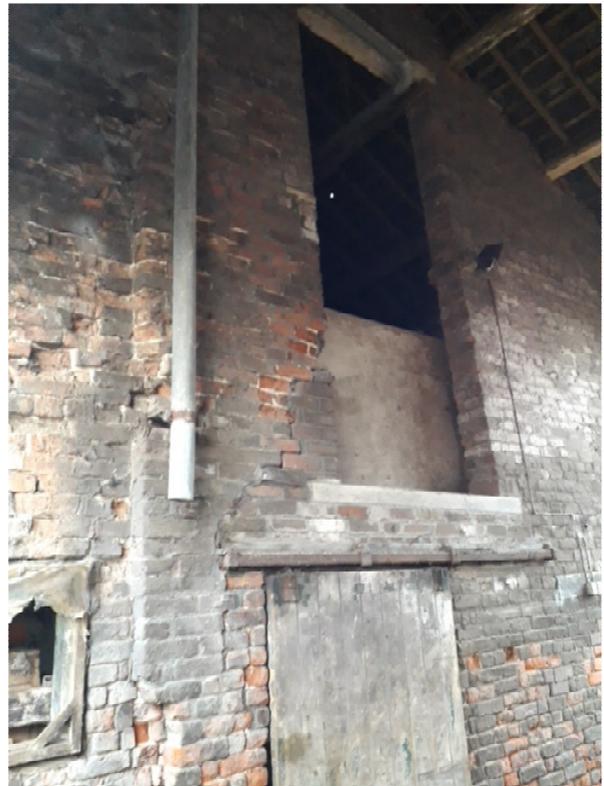
Figure 4: Cracking adjacent to existing openings

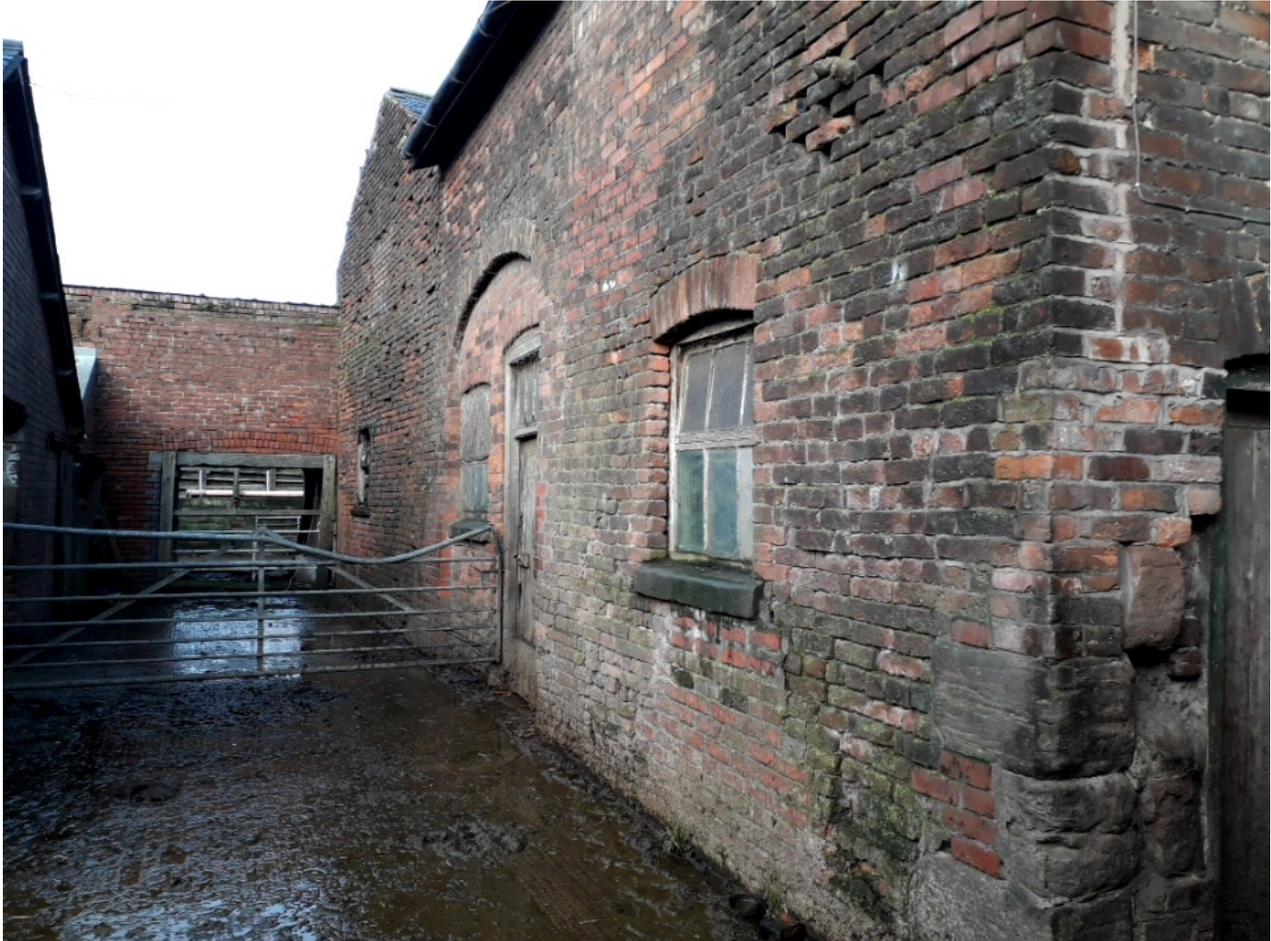
Masonry to the inner face of the courtyard unfortunately demonstrates similar conditions of poor repair, and as evident in Figure 5 facing towards the rear elevation of the entrance building, the facing has blown to large

areas of the masonry requiring replacement. There are also sections of previous replacement which have been poorly completed with mismatched masonry, and misalignment of jointing which should be addressed to restore the character of the building. Moving North the extent of blown facing to the façade increases significantly, particularly at high level where this will have been exposed to the elements more over the years. Signs of movement cracking exist again to the left-hand side of the window which would require repair.

Figure 5: View from inner courtyard
