Langtree PP and Panattoni

Six 56 Warrington

Addendum to Environmental Statement

Part 2 – Cultural Heritage & Archaeology

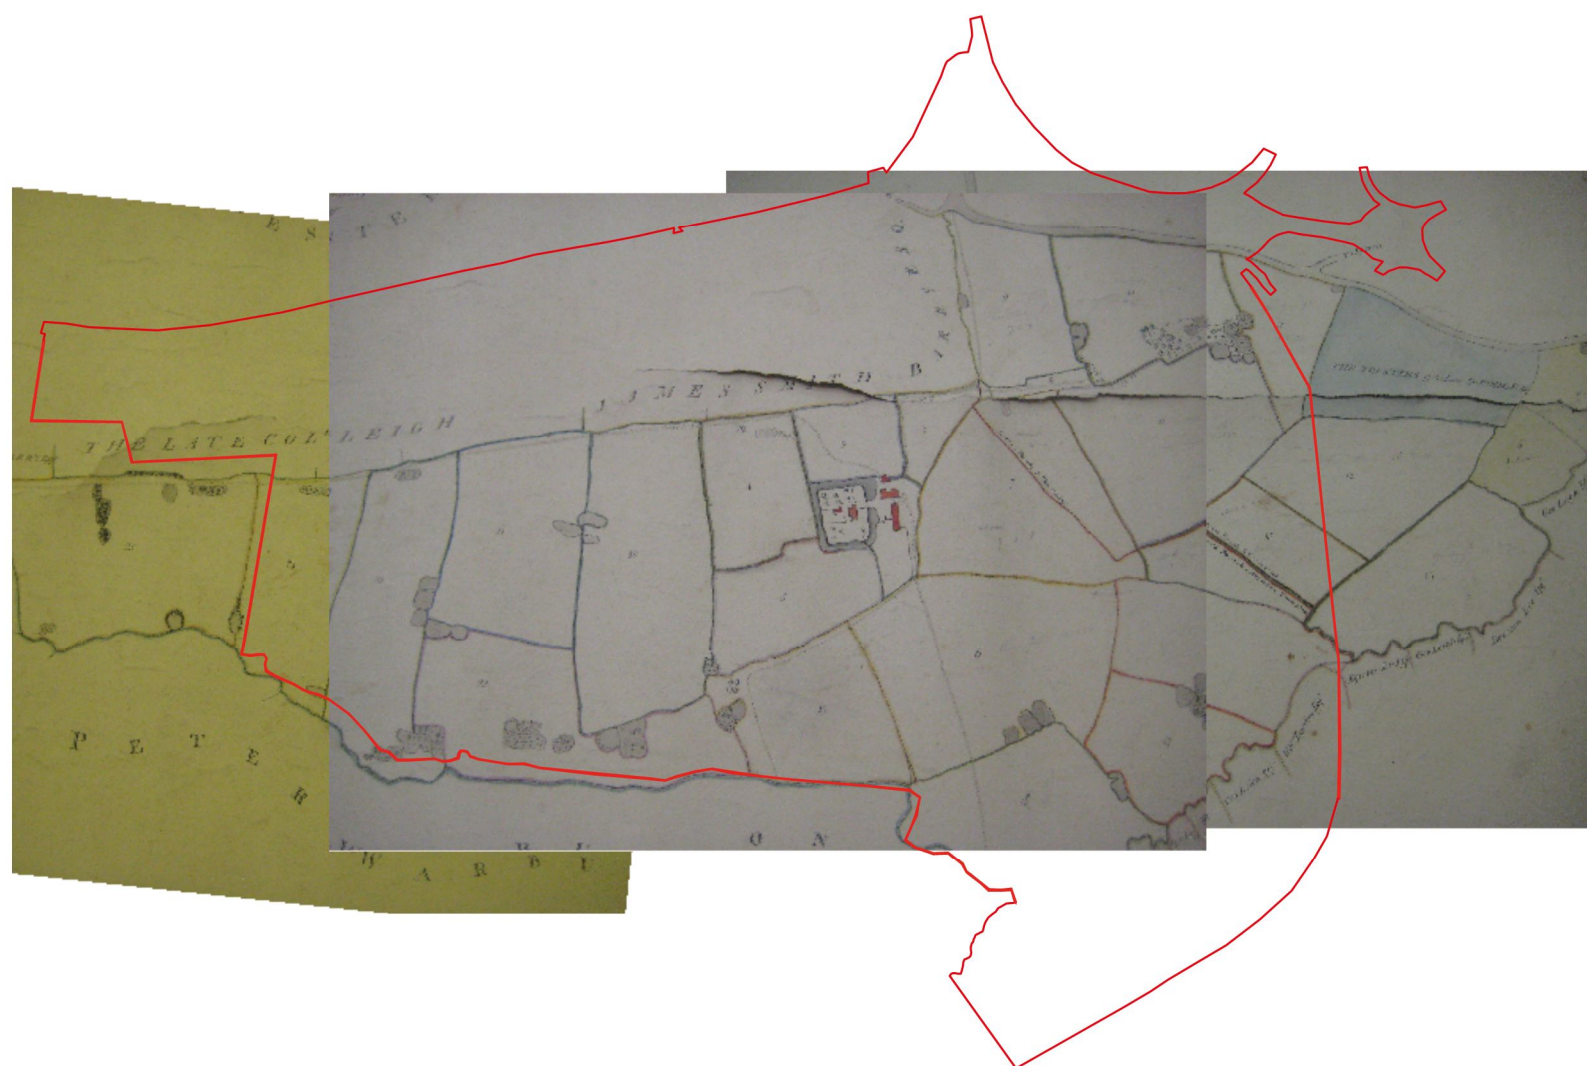
Figure 9.3 Extract from the Tithe map for the Parish of Great Budworth from 1847, showing the proposed development site (not to scale)

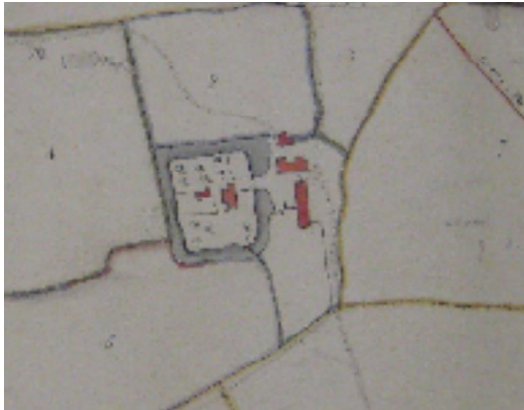
Insert 1 1820 Map of Cheshire showing first phase of Bradley Hall Farm

This courtyard arrangement was formed by extensions to the original early 19th century buildings shown on the 1820 Map of Cheshire (Inset 1) and the 1847 Tithe Map (inset 2).

Marked on the 1820 Plan of Cheshire is a rectangular structure which formed the southern part of the later mid-to late 19th century courtyard structure described above. To the north of this is a further structure whose position coincides with the later northern arm of the courtyard complex (see inset 1). South of these is a large rectangular building which is likely to have been associated. By the time the 1847 Tithe Map (see inset 2) was published only the southern arm of the later complex is marked suggesting that the other two structures were demolished. Further re-configuration or re-building is evident on the 1877 Ordnance Survey map as shown is

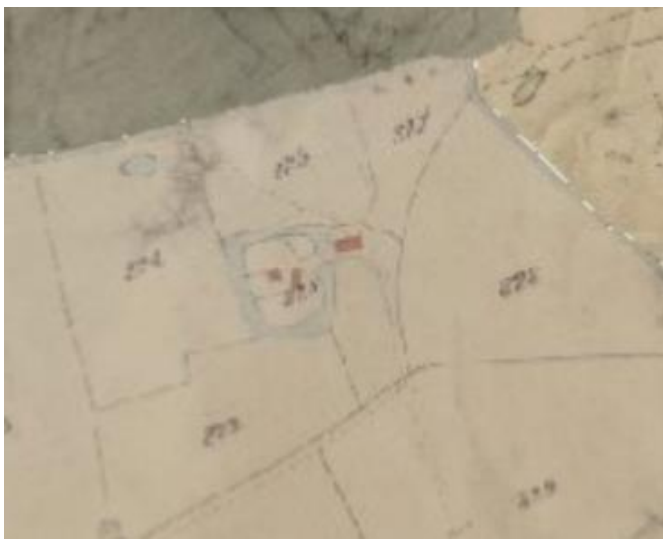
Insert 2 1847 Tithe Map showing Bradley Hall Farm

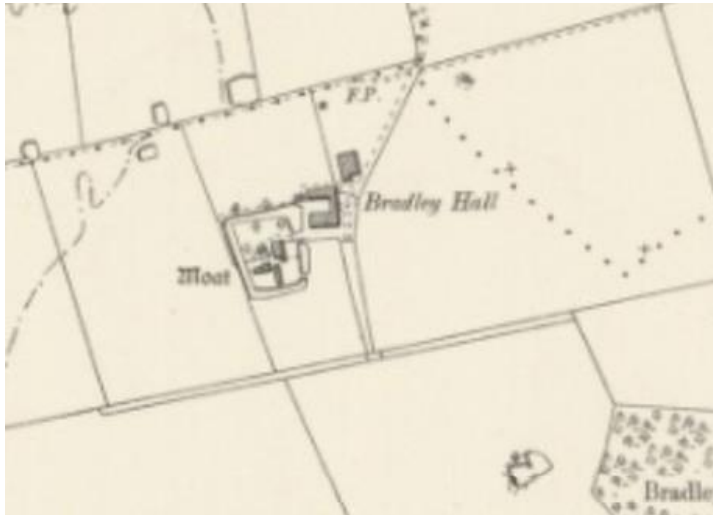
Insert 3 1899 Ordnance Survey map

the courtyard structure with central arched opening on its east side and lean-to structures on its northern arm. Smaller ancillary structures are also evident to the east and to the northeast, with the latter being the larger of the two. These structures did not last very long as in the late 1890s the larger one was replaced with a larger building and the other one demolished as shown on the 1899 edition (see insert 3)

This coincides with some re-modelling of the courtyard buildings, some infilling on the southern annex, the addition of a small lean to structure on the southern western tip of the lower courtyard range and the erection of a small rectangular building immediately to the west of the west side of the northern courtyard range. These changes are also shown on the 1910 Ordnance Survey map.

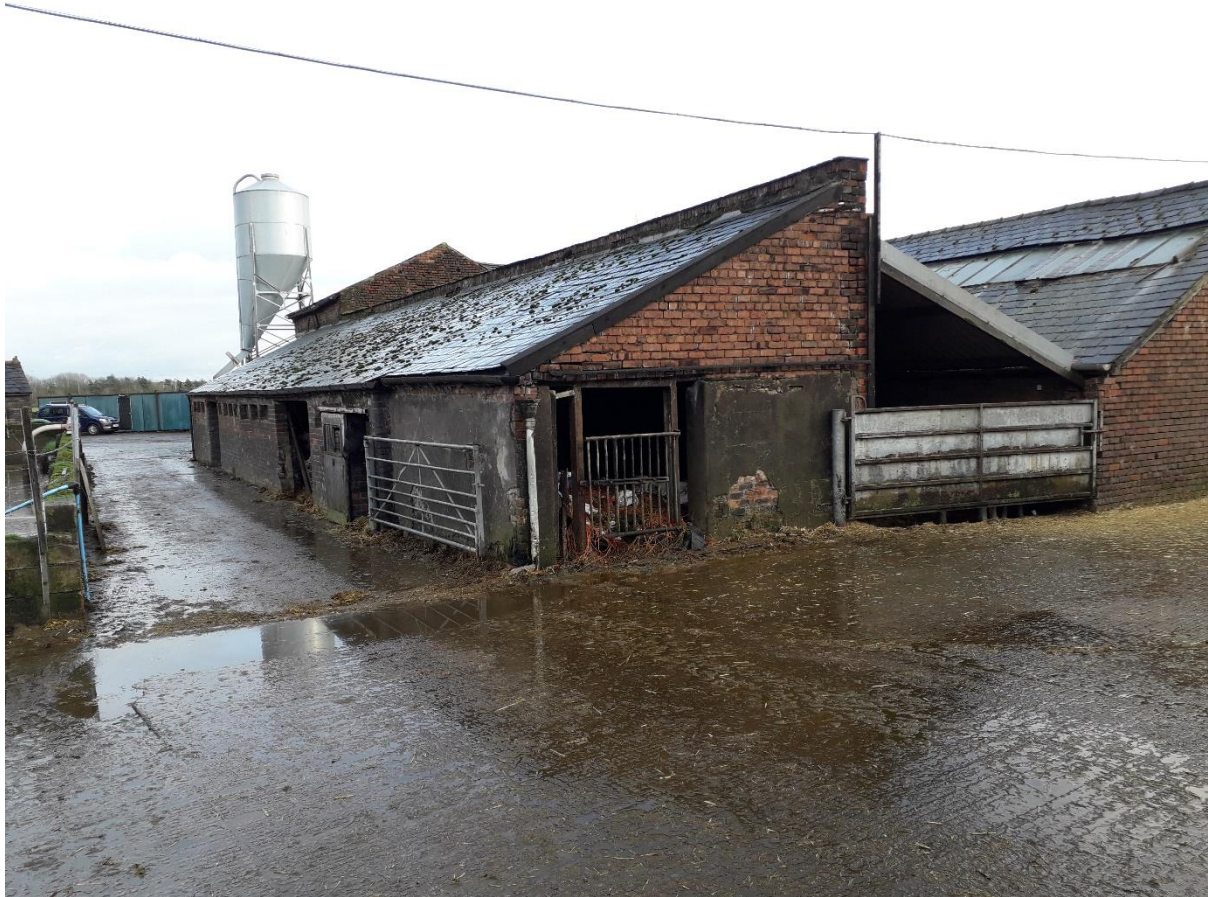
Plate 1 shows 20th century lean to added to outer wall of former northern range

but the northern range has been demolished bar the outer northern wall. This occurred between 1910 and the late 1960s as evident from historic maps. A lean to mono pitch structure was built on the north face of the surviving north range wall, with evidence for where it was tied in clearly visible (Plate 1).

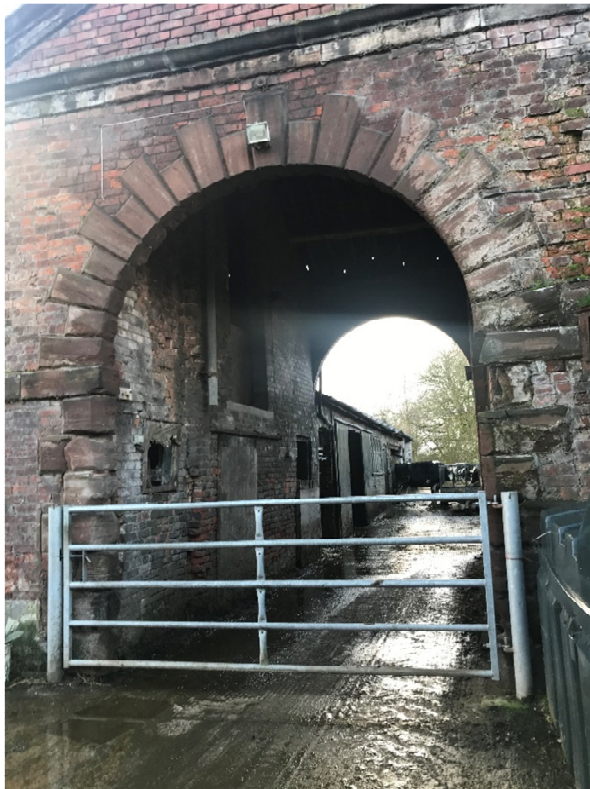
As can be seen from Figure 1 below, the primary arch demonstrates significant deterioration. The cornerstones to the left-hand side of the arch show significant loss of section due to weathering and would require extensive replacement to return to a serviceable position. Similarly, to the right-hand side extensive sections are demonstrating loss of section, and section of masonry patch repair, and would require extensive replacement. The surrounding face masonry is typically also in a poor condition, with sections of masonry which has lost the fired facing and would require replacement and extensive repointing.

Figure 1: View to central arch of barn

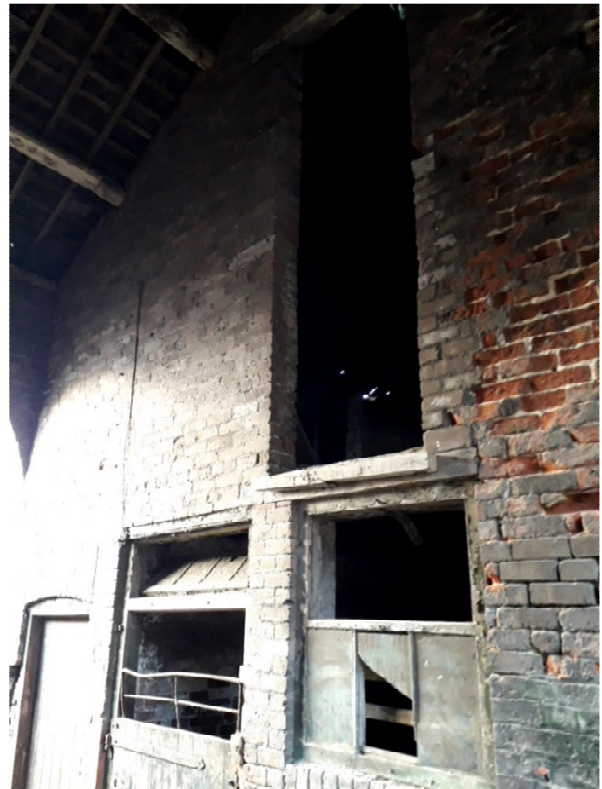
Figure 2: Extensive loss of masonry face to entrance

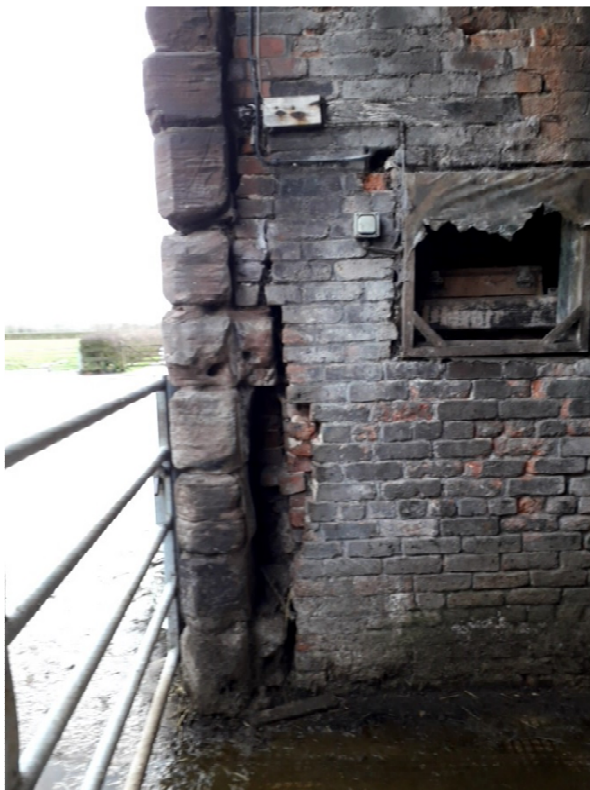
Similar defects are evident within the arch, particularly to the left-hand wall, and extensive areas of the wall would need rebuilding / repair to address issues of spalled facing (see Figure 2), and to more sympathetically restore previous modifications and bring back to a structurally stable condition. There were also signs of more significant structural defects including significant vertical cracking (see Figure 3 and 4).

Figure 3: Vertical cracking and separation to rear of entry arch

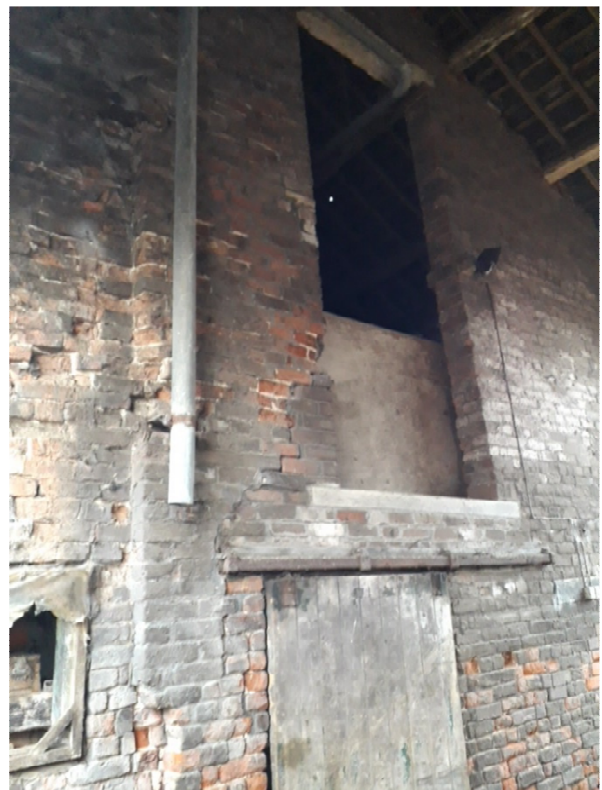
Figure 4: Cracking adjacent to existing openings

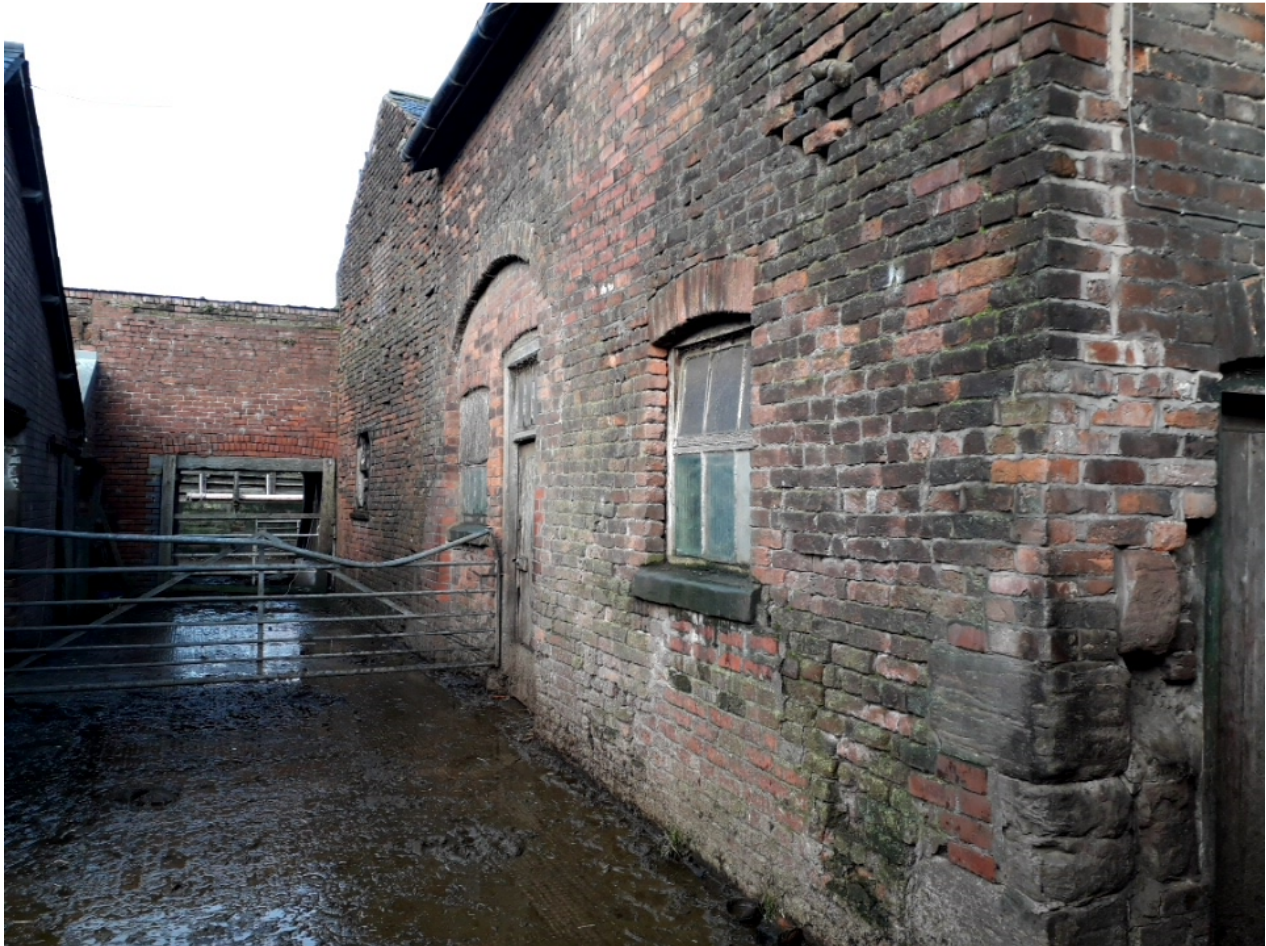
Masonry to the inner face of the courtyard unfortunately demonstrates similar conditions of poor repair, and as evident in Figure 5 facing towards the rear elevation of the entrance building, the facing has blown to large

areas of the masonry requiring replacement. There are also sections of previous replacement which have been poorly completed with mismatched masonry, and misalignment of jointing which should be addressed to restore the character of the building. Moving North the extent of blown facing to the façade increases significantly, particularly at high level where this will have been exposed to the elements more over the years. Signs of movement cracking exist again to the left-hand side of the window which would require repair.

Figure 5: View from inner courtyard
